The verification technology for the quality and reliability of parts

Kiyoharu Akimoto, Shinji Koyama

This article describes some effective solutions for increasing quality using structural analysis and inspection of parts.

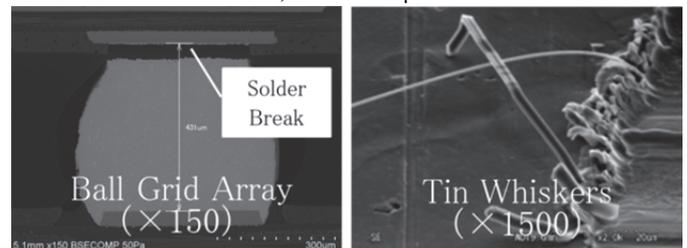
Figure 4 Example of SEM Images

Figure 4 shows a SEM micrograph (150x magnification) of a solder break in a BGA, and of 40-μm tin whiskers (1500x).

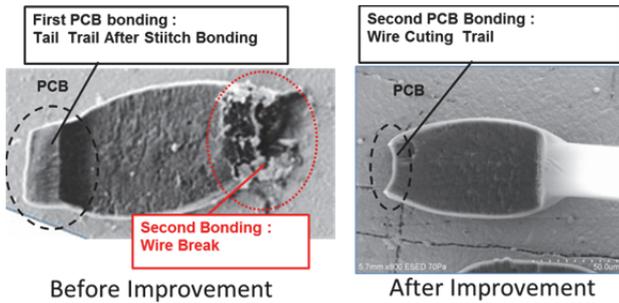
Figure 9 Magnified View of Wire Bonding

Figure 9 shows the wire bonding at the PC board side, comparing a good and bad process. In the bad process the bonding tip is convex compared to concave in the good process.

Wire bonding is a 2-step connection process and wire breaks are more likely to occur after the second bonding step, depending on which side is done first. At the second bonding step, the concave tip leaves a cutting scar. It would appear that the scarring is from the first bond in bad lots, while it is actually from the second bond.

Sharing these break analysis results with manufacturers has helped stabilize quality by standardizing on the wire bonding sequence.

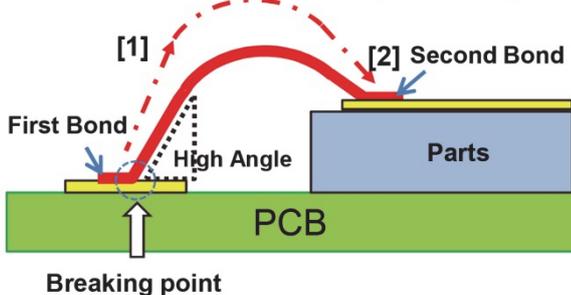
Figure 11 Schematic of Faulty Lot

Conversely, in a bad process, as shown in Figure 11, the angle of the wire is high from the first bond to the second bond. As a result, the base of the first bond is subjected to high tensile stress, causing the wire clip to potentially break.

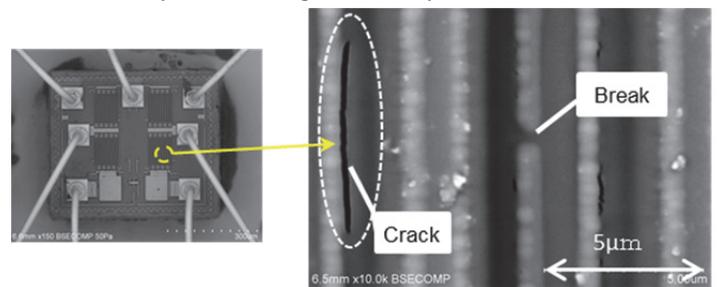
Figure 12 ESD Break in IC Chip (SEM)

As circuit traces become smaller due to the trend towards using lower voltages, immunity to high-voltage electrostatic discharge (ESD) is becoming lower and more ICs are suffering ESD damage. Figure 12 shows an example of using SEM for analysis of damage caused by ESD.

Trace breaks and cracks in various layers can be discovered by opening the IC package and scanning with a SEM. Due to the extremely microscopic damage, we generally believe that this damage is caused by ESD, and this type of damage is also increasingly present in high-frequency modules. As a countermeasure to this increase in damage from ESD, we have not only established an in-house inspection system but are also perfecting inspection by external agencies, manufacturers, and others.

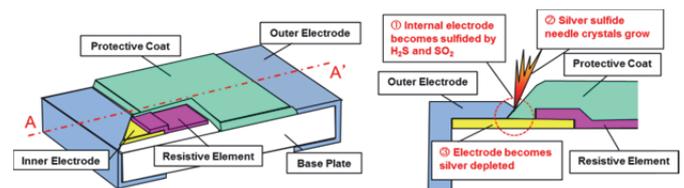
Figure 13 Cross-Section of Thick-Film Chip Resistor

Silver is commonly used for internal electrodes of thick-film chip resistors, but silver is easily corroded by atmospheric gases containing sulfur. Formation of silver sulfide (Ag₂S) causes growth of Ag₂S crystals with a needle like (whisker) form, depleting the electrode silver content and also causing short circuits. (Figure 13).

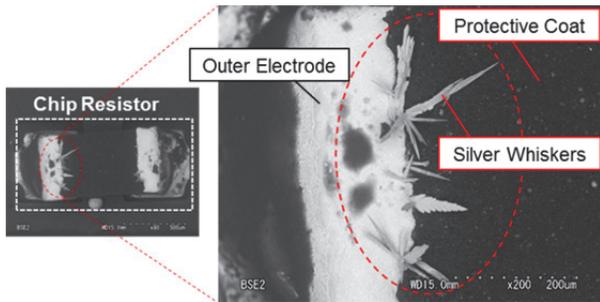
Figure 14 Silver Sulfide Crystal Formation (SEM)

Figure 14 shows silver whiskers growing on a thick film chip resistor.

An analysis using EDX (See Table 2 below) confirmed the presence of Ag and S in the parts and confirmed the existence of sulfide corrosion.

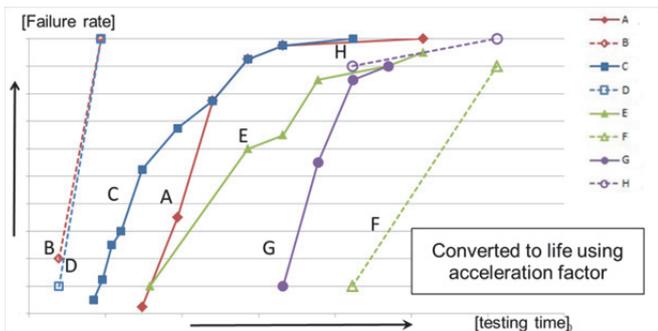
Figure15 Accelerated Sulfuration Resistance Test

The accelerated sulfuration test described in section 3.3 can be used to estimate the part's reliability from predetermined acceleration factors. Figure 15 shows examples for various types of chip resistor.

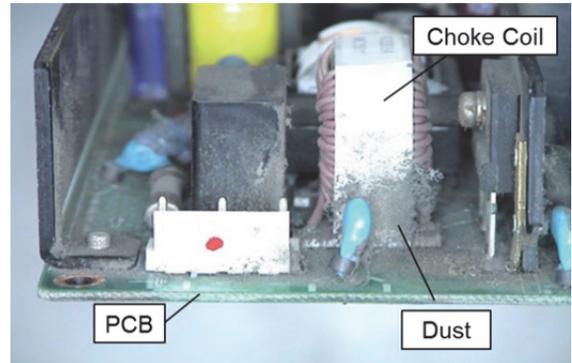
Figure 16 Internal View of PSU

Since the power supply unit in electrical equipment generates heat, ventilating cooling fans are used to disperse this heat. However, the ventilation air moved by the fans also pulls in dust and dirt, which can cause faults. Figure 16 shows an example of a failed PSU contaminated by dust and

corrosion. The picture shows a large volume of accumulated dust between the choke coil and PC board. EDX analysis of this dust (Table 3) confirms the presence of high chlorine (Cl) levels.

This corrosion is due to the presence of Cl in the dust and humidity in the ventilation air. Dusty and contaminated atmospheric air is common in NIEs where these faults are becoming increasingly common. As a countermeasure, specifying protective dust filters and PC board coatings at the design stage is effective, and parts manufacturers are being urged to use these countermeasures for their production as well.

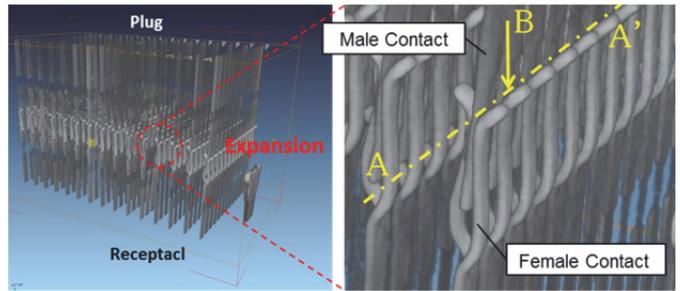
Figure 19 Connector (Fitting Condition) CT Scan Stereoscopic Image

These connectors use a stacked contact structure (vertical connections between horizontally arranged PC boards). The cause of poor connections is due to misalignment of the pins, thereby shorting when the male side of the connector is inserted into the female side.

The left side of Figure 19 shows a CT scanned stereoscopic image of the mating surfaces between the connector plug and socket, the right side is a magnified part of the image.

To prevent contact faults in high-pin-density multi-pole connectors, it is necessary to establish design and mounting rules to minimize deformation during insertion. In addition, it is also necessary to use multi-pole connectors with insulating structures between contacts. The X-ray CT scanner makes it possible to detect the condition of internal mating surfaces and it is very effective in finding mating conditions that can lead to failures.

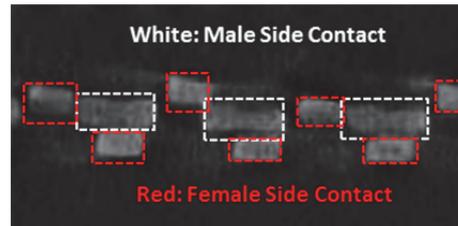
Figure 20 CT Scan of Contact Shorting

Figure 20 shows a cross-section CT scan of the contact conditions seen from the B side of the A-A' section in Figure 19.

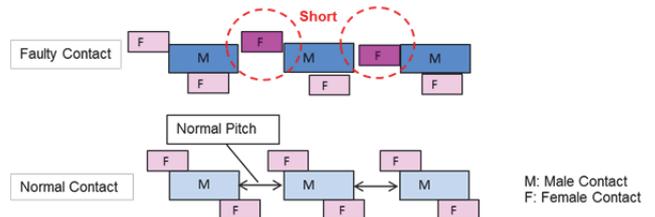
Figure 21 Faulty Contact Conditions

Figure 21 shows the diagnostic analysis of the connector, confirming abnormal mating surfaces between the male and female sides of the connector.
