Anritsu - GRL

USB 3.1 Rx Test Application

Release Note

Sixth Edition

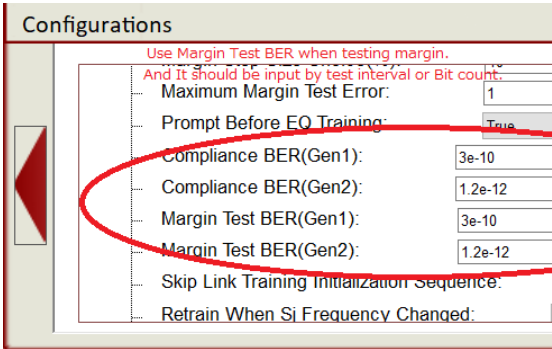
Version	Item (Management Number)	Issue
V1.00.116	A bug causing Margin Test to refer to a wrong parameter.	<p>Though Margin Test for Gen1/2 should refer to the Margin Test BER value as the threshold, it refers to the Compliance BER value.</p>

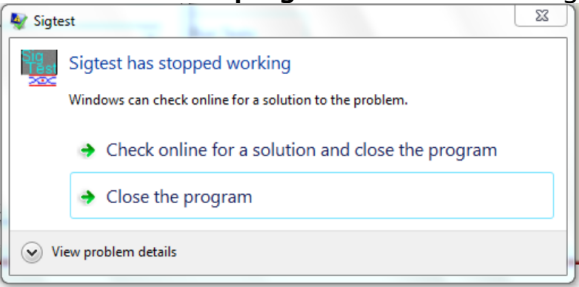
Problems	Description
<p>A SigTest error message is displayed when calibrating EH/EW.</p>	<p>Sometimes a SigTest error message is displayed and SigTest has stopped working when calibrating EH/EW. Click on Close the program when the message is shown.</p>

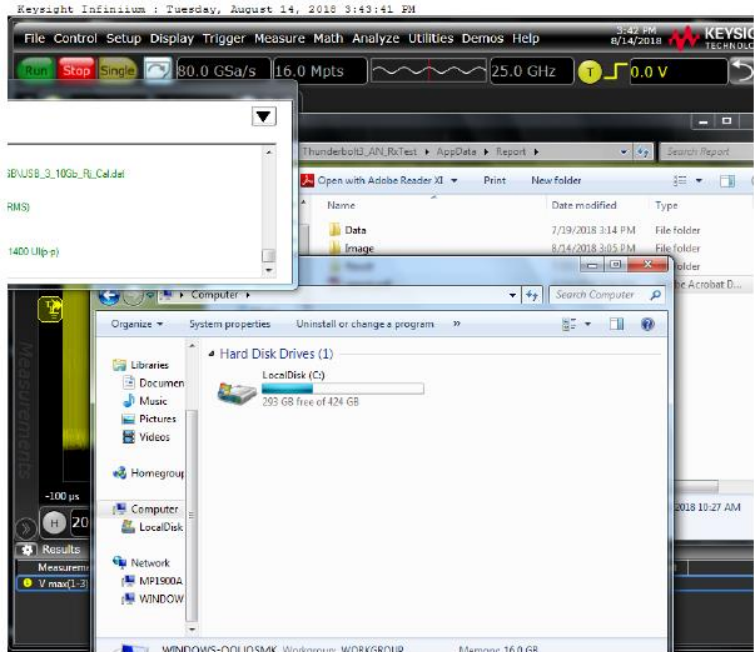
<p>Waveform screenshots in a report include other software windows.</p>	<p>Other software windows are overlapping the waveform images. When operating other software, using an external display is recommended.</p>
