# Technical Note

Vol.13  
2020/12

## Tips for Effective Use of Checkweigher: A Zero-Set Error

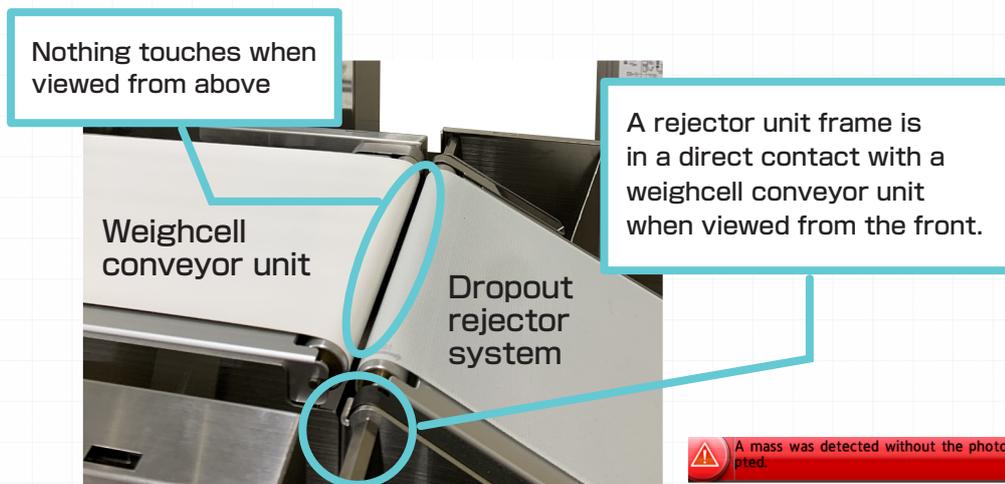
**Causing factor 1** When our support technicians receive calls from customers, they always ask them to check if a rejector system or a cable touches the weighcell conveyor section to identify the cause of the error. Even when customers told our technicians on the phone that nothing touches the weighcell conveyor section, there are many cases where our service technicians confirm the weighcell conveyor section in contact with a rejector at the site.

Fig.3 Dropout rejector touches weighcell conveyor unit

When the error message on the operation screen does not go out by pressing the zero-set button, check if a rejector, cables from a sensor and motor touch the weighcell conveyor section not only from the above but also from the side and front.

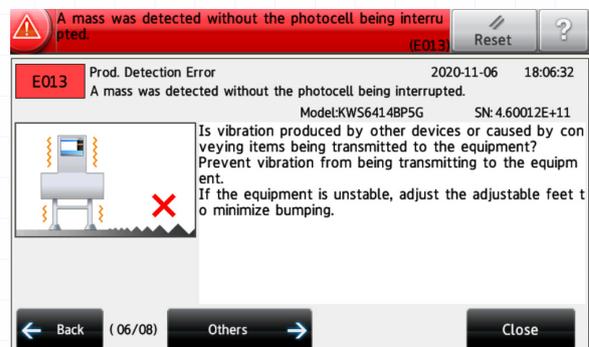
Fig.4 Error message on operation screen (Anritsu checkweighers)

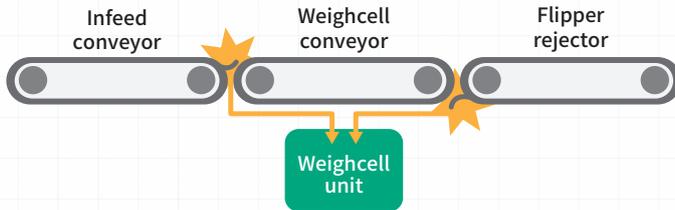
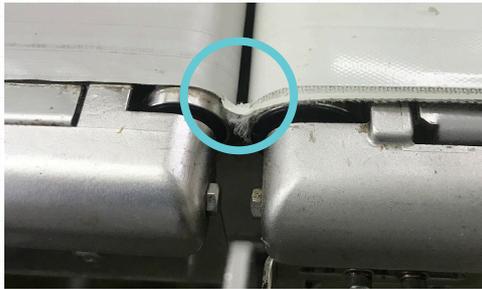
**Causing factor 2** When belts on the infeed conveyor section and a rejecter get frayed and turned up on the edge due to deterioration, frayed parts may pat or tap the weighcell conveyor in a constant period. As mentioned previously, when the external stress is applied to a checkweigher at the timing of performing auto zero setting, zero-point adjustment cannot function correctly and measurement error may become large.

Fig.5 Frayed belt touches weighcell conveyor section

Remove a conveyor belt periodically to check for any fraying or peeling on the edge. If you see any warp or fray on the belt, please change it for a new belt or cut off the fraying part to prevent it from blocking a sensor.

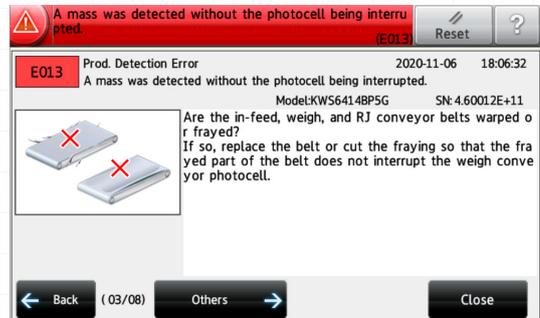
Fig.6 Error message on operation screen (Anritsu checkweighers)

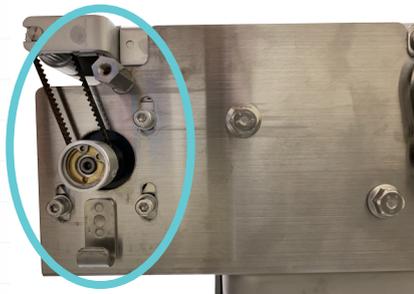
**Causing factor 3** Unexpectedly it is not well known that zero-set error occurs when the user forgets to attach main parts including optional parts. For instance, after the end of production, a user removes a drive belt cover, a product guide, and a cross plate for cleaning and forgets to attach one of them. The load applied to a weighcell becomes lighter and the indicated value on a screen shows at a minus side. In particular, users forget to attach a drive belt cover. Starting the conveyor with a missing machine part can generate a zero-set error.

Fig.9 Without a drive belt cover

Please make sure that all parts of the weighcell conveyor unit are attached. After the end of checking, press the zero-set button.

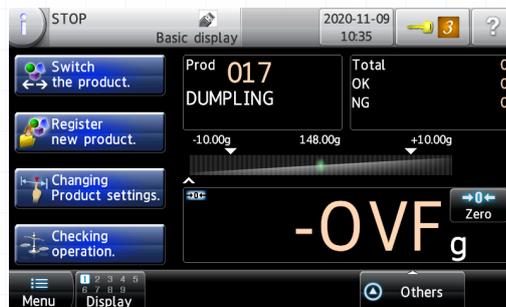
Fig.10 Zero set error by forgetting to attach a drive belt cover

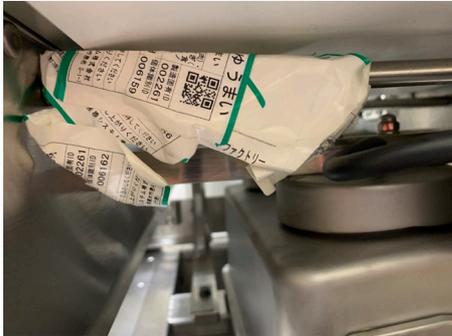
**Causing factor 4** Poor cleaning can generate a zero-set error. Nutrition facts label from the product, rice grains of rice balls leaked outside due to poor packaging ingredients spillover from a container before sealing, etc. can fall and accumulate on or under the weighcell conveyor, in a space between the surface of the joint parts. The load exceeding correction range is being applied to the weighcell. Especially when machine cleaning work is outsourced, users notice the presence of dust and food residue accumulated for the first time when a zero-set error occurs.

Fig.11 A product label wound around the stand

Air blowing is one way of removing dust and food residue; however, they can sneak into the gap in the blind area. We recommend using a cloth for cleaning.

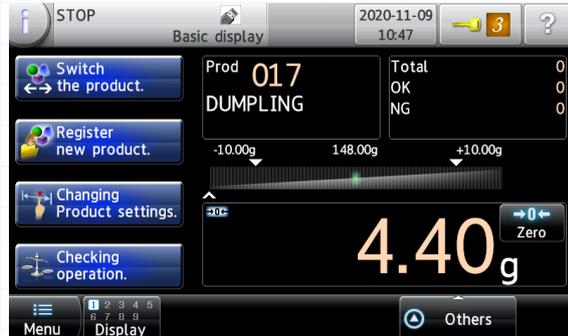
Fig.12 Zero point deviated at the plus side by a label

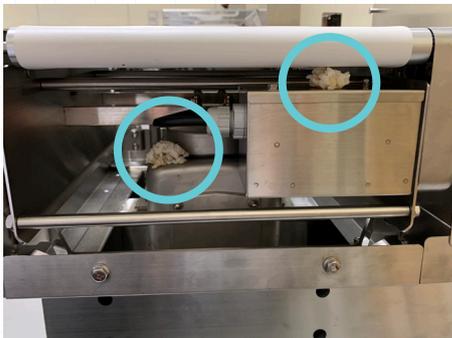
Fig.13 Rice grains accumulated in the weighcell unit and a motor cover

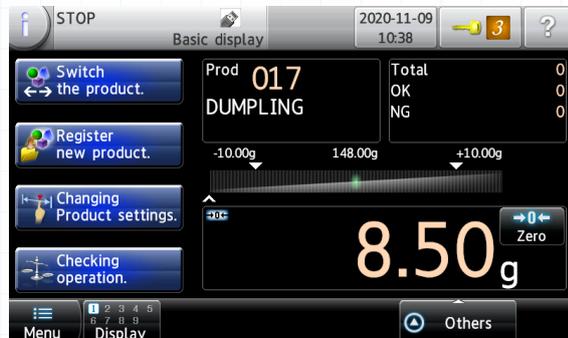
Fig.14 Zero point deviated at the plus side by rice grains
