# Technical Note

## Tips for Effective Use of Checkweigher: A Zero-Set Error

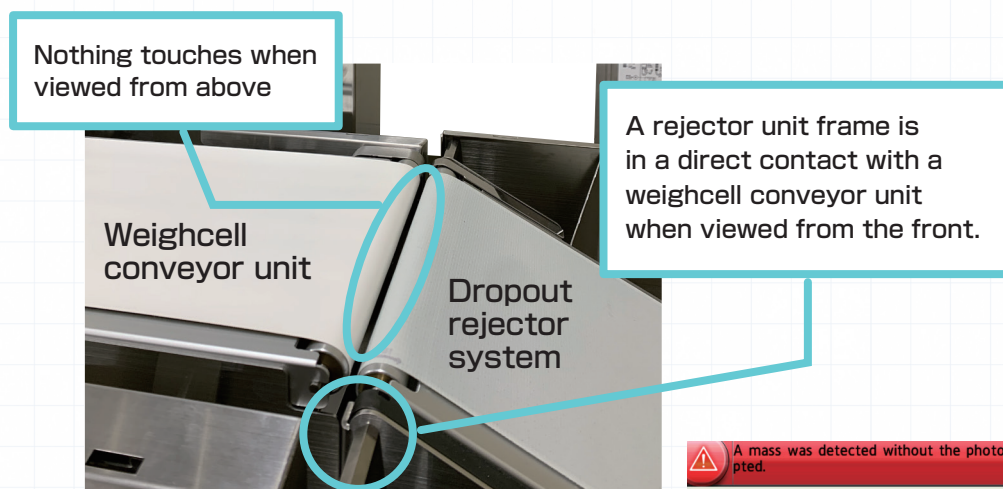
**Causing factor 1** When our support technicians receive calls from customers, they always ask them to check if a rejector system or a cable touches the weighcell conveyor section to identify the cause of the error. Even when customers told our technicians on the phone that nothing touches the weighcell conveyor section, there are many cases where our service technicians confirm the weighcell conveyor section in contact with a rejector at the site.

Fig.3 Dropout rejector touches weighcell conveyor unit

When the error message on the operation screen does not go out by pressing the zero-set button, check if a rejector, cables from a sensor and motor touch the weighcell conveyor section not only from the above but also from the side and front.

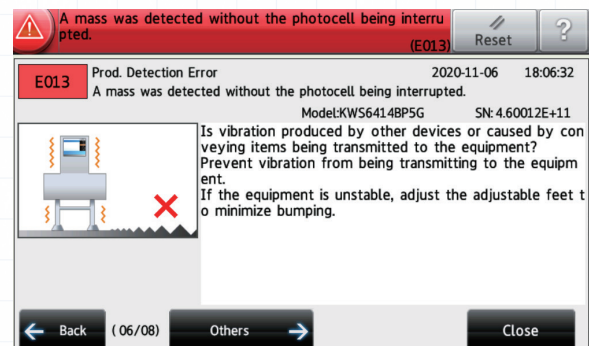
Fig.4 Error message on operation screen (Anritsu checkweighers)

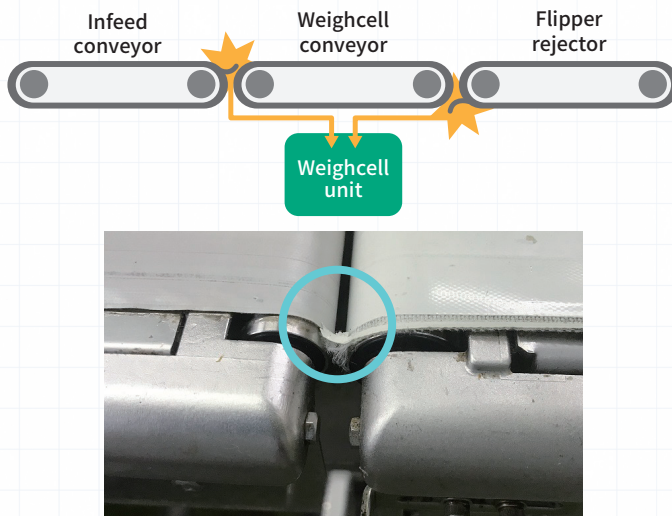
**Causing factor 2** When belts on the infeed conveyor section and a rejector get frayed and turned up on the edge due to deterioration, frayed parts may pat or tap the weighcell conveyor in a constant period. As mentioned previously, when the external stress is applied to a checkweigher at the timing of performing auto zero setting, zero-point adjustment cannot function correctly and measurement error may become large.

Fig.5 Frayed belt touches weighcell conveyor section

Remove a conveyor belt periodically to check for any fraying or peeling on the edge. If you see any warp or fray on the belt, please change it for a new belt or cut off the fraying part to prevent it from blocking a sensor.

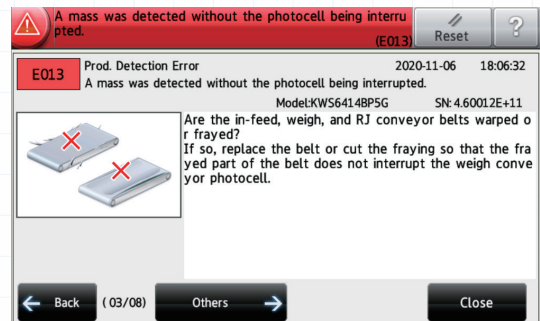
Fig.6 Error message on operation screen (Anritsu checkweighers)

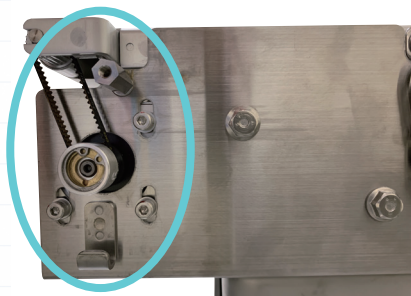
**Causing factor 3** Unexpectedly it is not well known that zero-set error occurs when the user forgets to attach main parts including optional parts. For instance, after the end of production, a user removes a drive belt cover, a product guide, and a cross plate for cleaning and forgets to attach one of them. The load applied to a weighcell becomes lighter and the indicated value on a screen shows at a minus side. In particular, users forget to attach a drive belt cover. Starting the conveyor with a missing machine part can generate a zero-set error.

Fig.9 Without a drive belt cover

Please make sure that all parts of the weighcell conveyor unit are attached. After the end of checking, press the zero-set button.

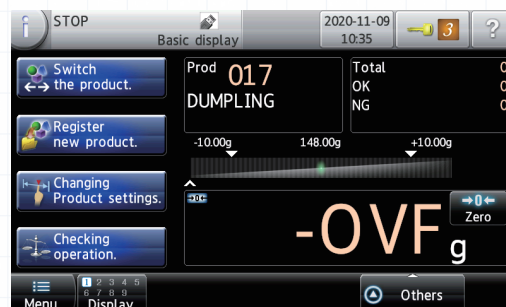
Fig.10 Zero set error by forgetting to attach a drive belt cover

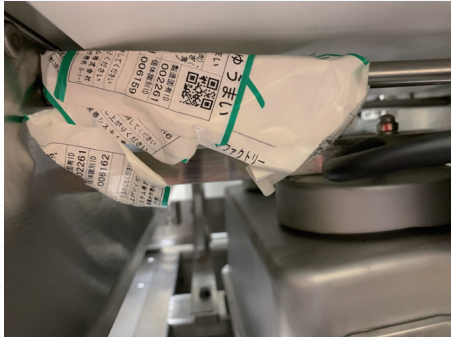
**Causing factor 4** Poor cleaning can generate a zero-set error. Nutrition facts label from the product, rice grains of rice balls leaked outside due to poor packaging ingredients spillover from a container before sealing, etc. can fall and accumulate on or under the weighcell conveyor, in a space between the surface of the joint parts. The load exceeding correction range is being applied to the weighcell.

Fig.11 A product label wound around the stand

Air blowing is one way of removing dust and food residue; however, they can sneak into the gap in the blind area. We recommend using a cloth for cleaning.

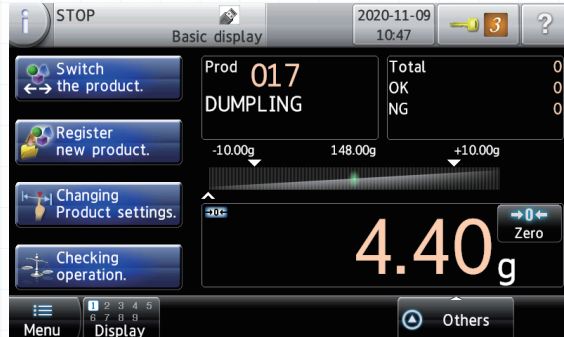
Fig.12 Zero point deviated at the plus side by a label

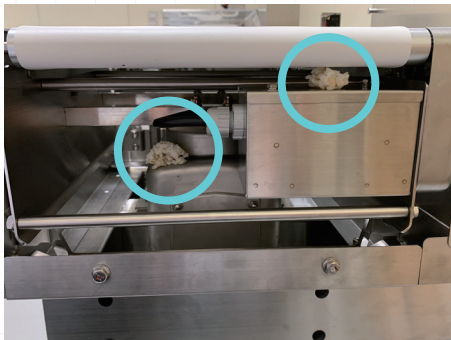
Fig.13 Rice grains accumulated in the weighcell unit and a motor cover

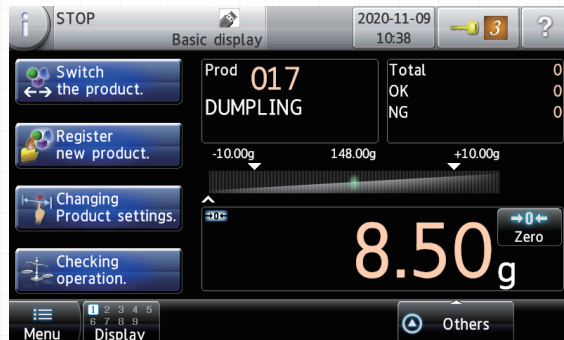
Fig.14 Zero point deviated at the plus side by rice grains
