Anritsu - GRL

USB 3.2 Rx Test Application

Release Note

10th Edition

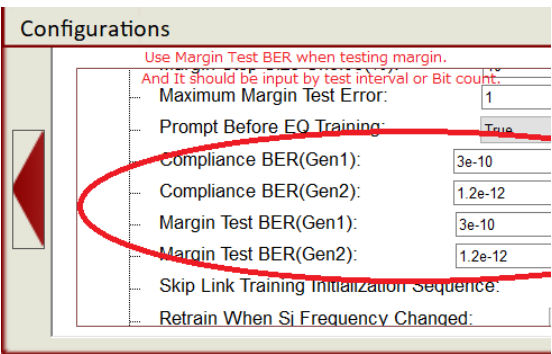
Version	Item (Management Number)	Issue
V1.00.116	A bug causing Margin Test to refer to a wrong parameter.	<p>Though Margin Test for Gen1/2 should refer to the Margin Test BER value as the threshold, it refers to the Compliance BER value.</p>

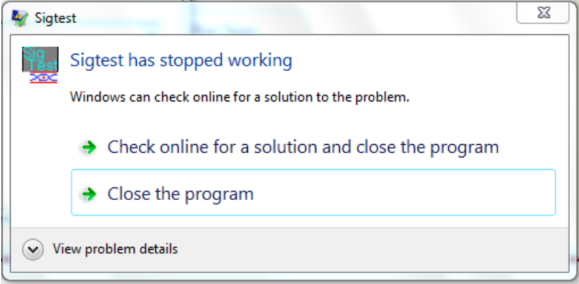
Problems	Description
<p>A SigTest error message is displayed when calibrating EH/EW.</p>	<p>Sometimes a SigTest error message is displayed and SigTest has stopped working when calibrating EH/EW. Click on Close the program when the message is shown.</p>

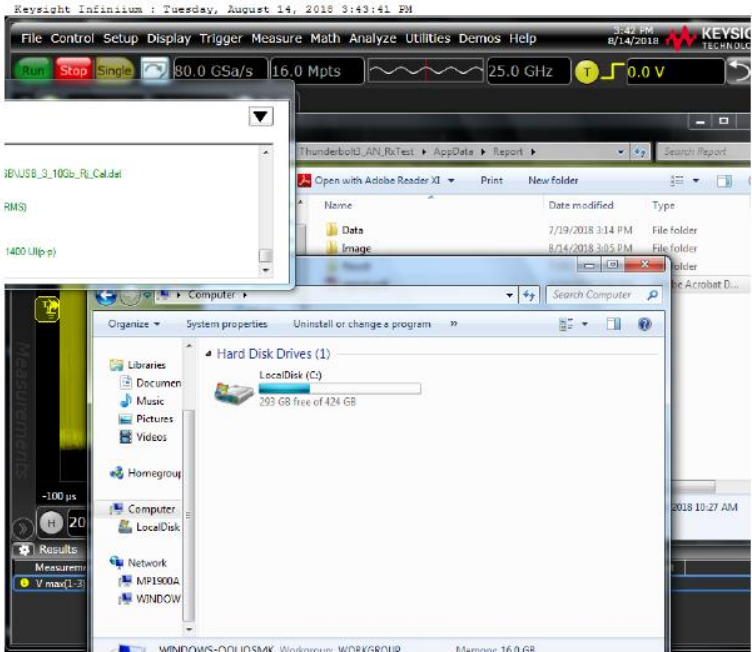
<p>Waveform screenshots in a report include other software windows.</p>	<p>Other software windows are overlapping the waveform images. When operating other software, using an external display is recommended.</p>
