# MT9085 Series ACCESS Master

## Release Notes

Version 3.00

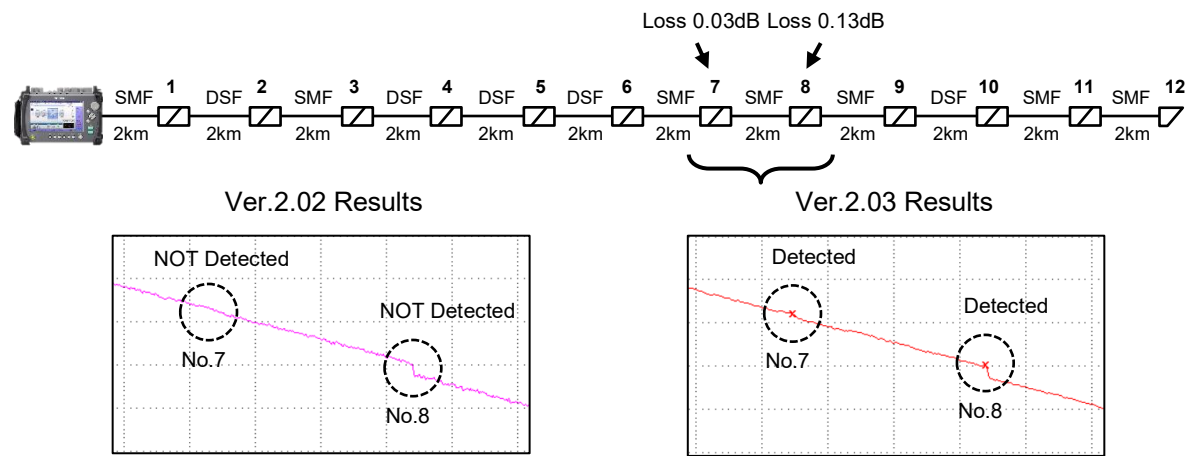
### (Improvement Example 1)

Ver. 2.02 or earlier occasionally failed to detect such low loss events as shown below. Ver. 2.03 can detect these events.

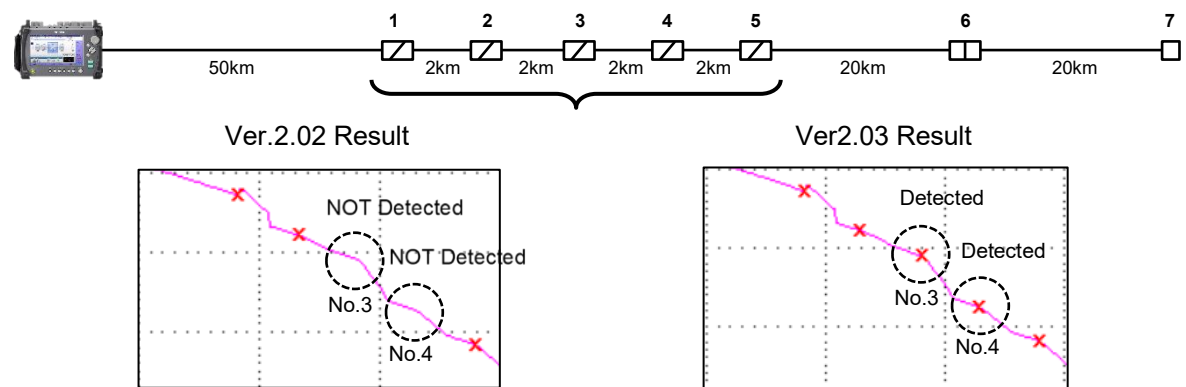
(Improvement example 2)

Ver. 2.02 or earlier occasionally failed to detect some of adjacent events existing in the long-distance fiber as shown in the figure below. Ver. 2.03 can detect these events.
