Technical Note

Measures to Prevent False Rejects in Metal Detectors: External Noise Part 2

Issued in October 2024 ANRITSU CORPORATION. Sales Promotion Section, Marketing Division.
DOC.NO. TNG2410-022EN-00

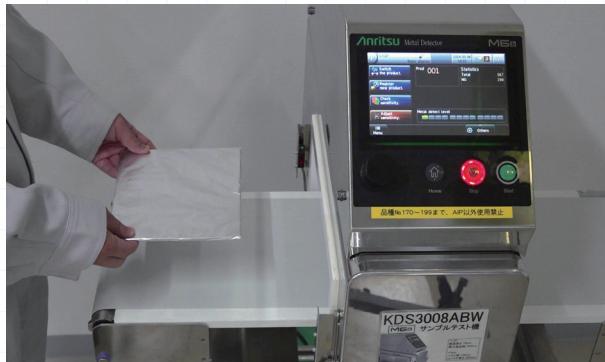
【Stationary state】

The metal plate was held in hand and kept in a stationary position approximately 8 cm in front of the detection head. The indicator of the metal detector remains green. There is no disturbance in the magnetic field.

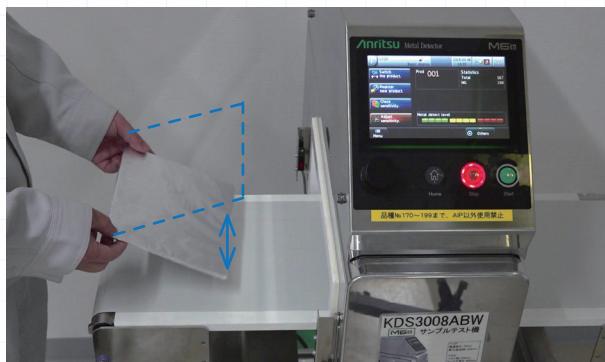
【When shaken】

The metal plate was moved up and down at the same position. you can see that the magnetic field is disturbed, and the indicator is swinging to the limit.

From this experiment, we can see that the metal parts near the detection head could potentially affect a metal detector's magnetic field when they vibrate. Now, let's take a look at some examples that frequently occur on the actual production line.

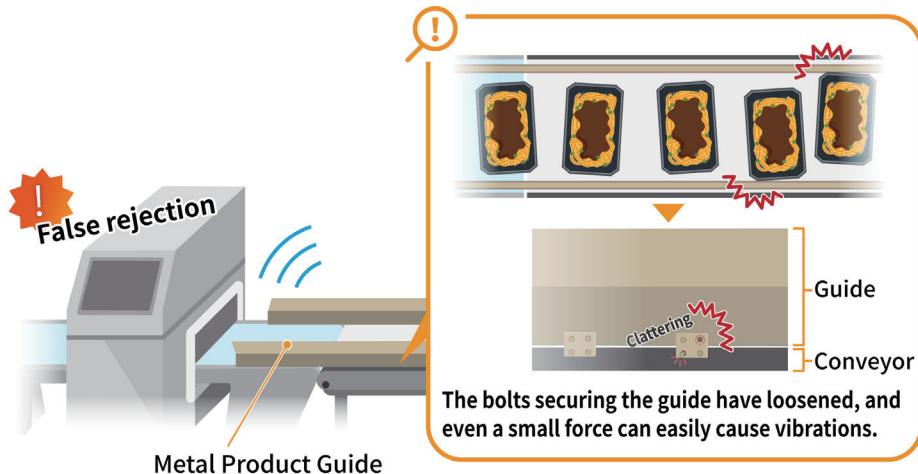
【Loosening of fittings】

If the metal product guide for the upstream conveyor extends over the conveyor of the metal detector, the guide will vibrate when the product collides, causing noise that can lead to false rejects.

1. Regularly tighten the bolts ensuring there is no looseness.
2. If that does not solve the problem, change the metal product guide to a resin one.

Yet, be cautious as the resin can degrade and may break off. We provide a Guide Bank that does not come into direct contact with the inspected item for non-packaged products.

The same phenomenon might occur if the bolt of the stainless steel crossing plate which smoothly transfers from the upstream conveyor to the conveyor of the metal detector loosens up. As the camera stand attached to the chassis may shake if the fixing stay does not have adequate strength, it is recommended to place it in a different location.

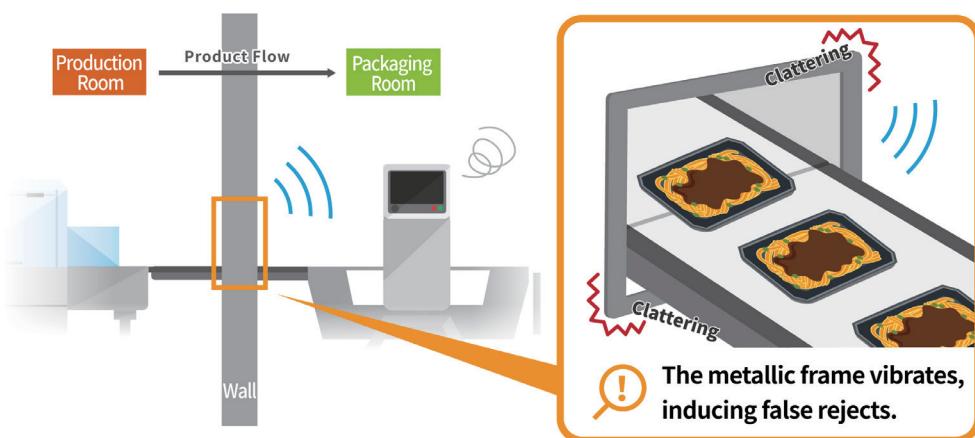
【Metal frame of the wall separating production and packaging rooms】

As shown in the figure, if the aluminum or stainless steel frames on the wall separating the production room and the packaging room are loose, the magnetic field of the metal detector in the packaging room may be disturbed and false rejection may occur.

Glue or bolt the frame to prevent it from vibrating.

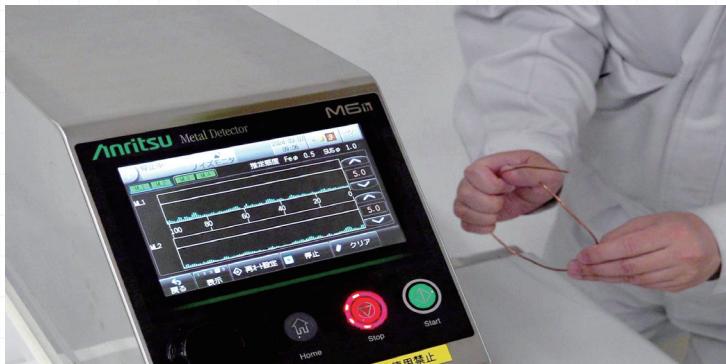
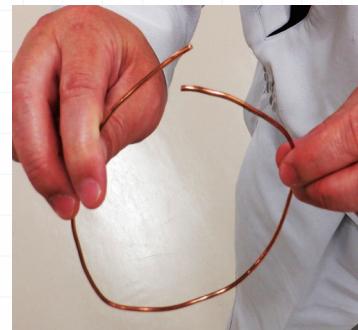
【Released state (enlarged view)】

The copper wire is coiled up, but the indicator hardly fluctuates in a state where both ends are separated.

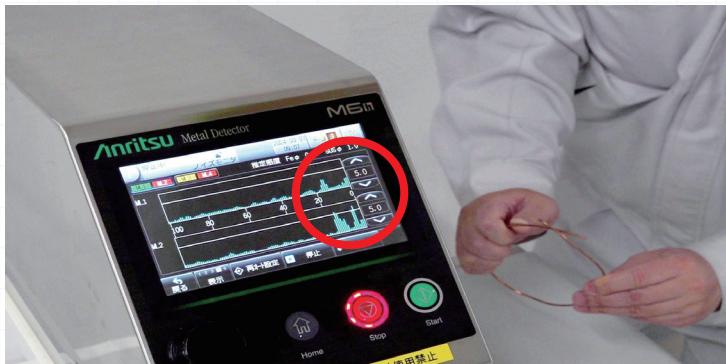
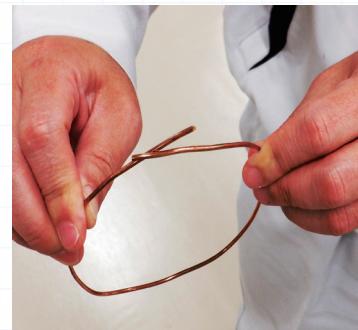
【In contact (enlarged view)】

When both ends of the wire are made to touch, creating a loop shape, the indicator oscillates significantly for a while.

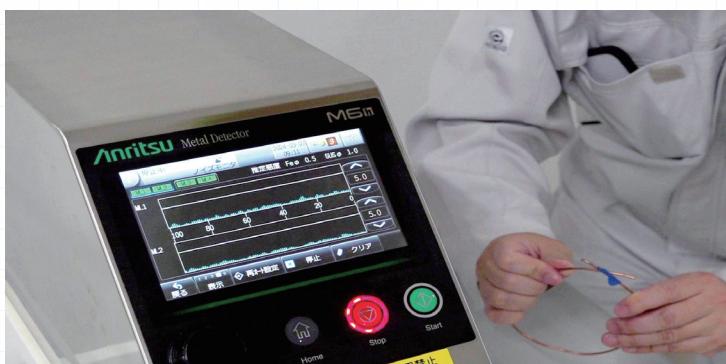
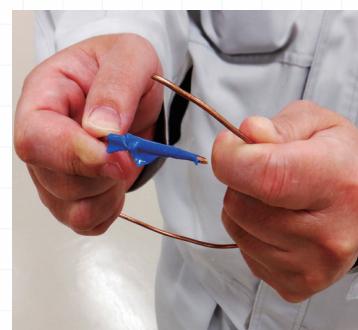
【Insulated state where vinyl tape was wrapped (enlarged view)】

By wrapping one side with vinyl tape it becomes insulated, and even when both ends touch the swing of the indicator is minimal.

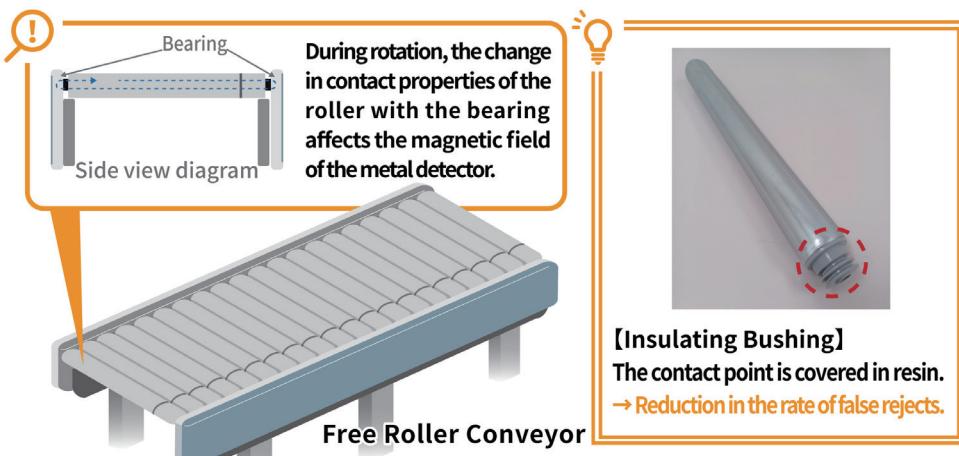
[Free Roller Conveyor]

When a free roller type conveyor is used in the upstream and the downstream, it is possible the insulating bushing may come off during cleaning. If the shaft of the roller with the removed bush directly touches the bearing of the conveyor casing, the degree of contact will subtly change during rotation, causing the electromagnetic waves generated to disrupt the magnetic field of the metal detector.

After cleaning, check that the insulating bushing has not come off, and if it has come off, reattach the bushing.

(Note) There are free roller conveyors that don't include an insulating bushing.

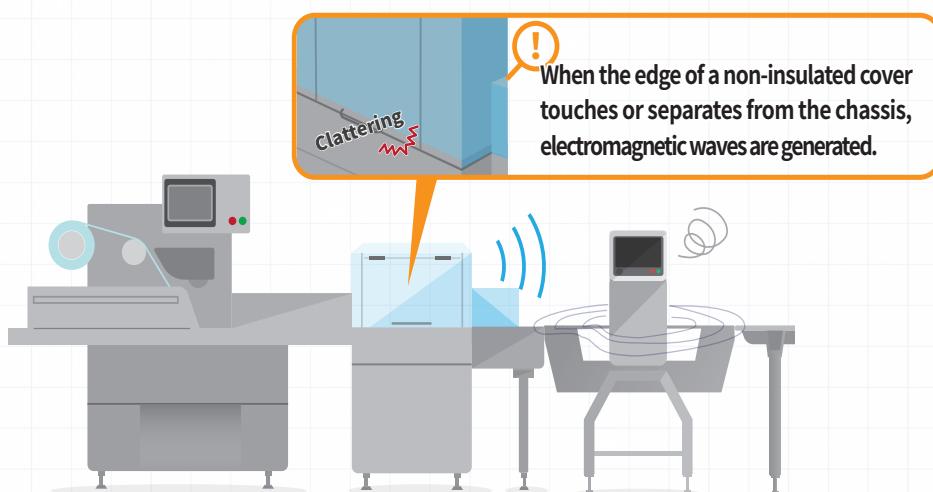
[Metal openable/closable cover]

Meanwhile, with the presence of metal openable/closable covers installed on a packaging machine placed at the upstream of a metal detector, electromagnetic waves may be generated just by the edge of the cover touching or moving away from the chassis.

Please refer to the reference material "Insulation Measures" at the end of this paper.

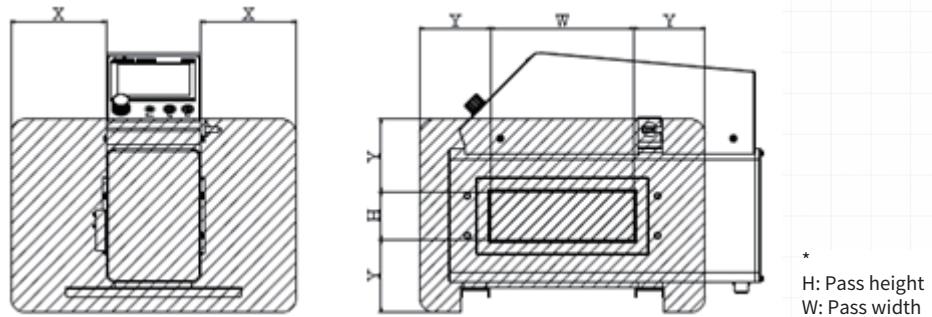
【Distance to avoid installing metal objects】

Caution: If the size of the moving metal is large, false rejection may occur even if the metal object is outside the following range.

(7) To avoid the effect of magnetic fields, do not allow any of the metallic objects listed in (1) to (4) near the metal detector within the shaded parts in the drawing below.

- [1] Fixed metallic objects;
- [2] Rotating metallic objects such as rollers and bearings;
- [3] Moving metallic objects such as cams and links;
- [4] Electromagnetic parts such as solenoids and clutches that might generate magnetic fields.

See the table below for X and Y.

Item	X	Y
[1] Fixed metallic objects	2 h	1.5 h
[2] Rotating metallic objects such as rollers and bearings	3 h	2 h
[3] Moving metallic objects such as cams and links	3.5 h	2.5 h
[4] Electro-magnetic parts such as solenoids and clutches that may generate magnetic field	4 h	3 h

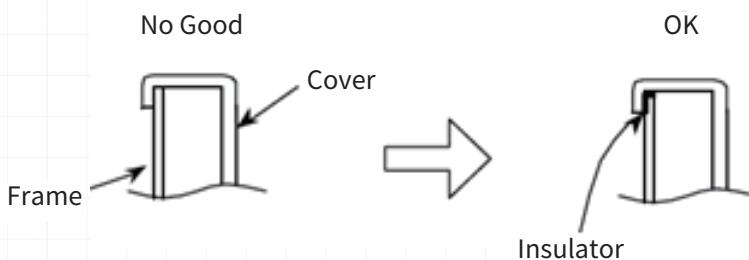
【Insulation measure】

(2) Do not construct covers such as motor covers to hook on the frame and secure them using screws instead. Insert an insulator when one metal portion is constructed to repeat contact and non-contact with another metal portion.
