Uncovering Interference at a Co-Located 800 MHz P25 Public Safety Communication System

RTSA Spectrum Analyzer Key to Uncovering Hard-to-Find Cause

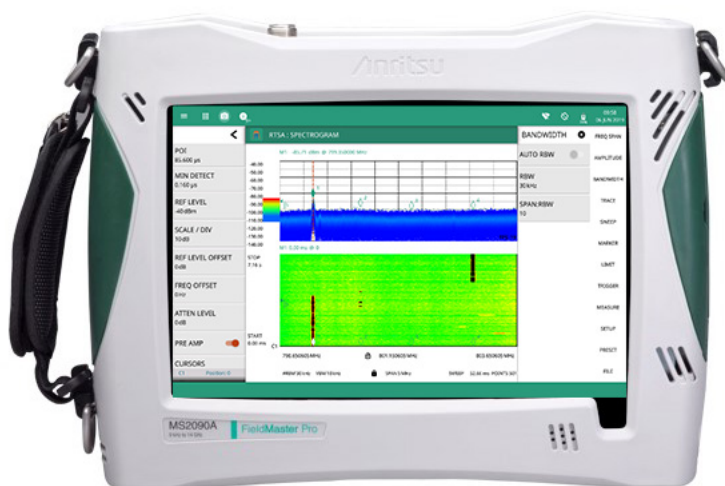
Figure 1. Anritsu Field Master Pro MS2090A with optional RTSA.

Anritsu's Field Master Pro™ MS2090A solution with real-time spectrum analyzer option was selected to locate the interfering signal (Figure 1). The Field Master Pro MS2090A has an optional real-time mode that can accurately measure the amplitude of a single spectrum event as short as 2 μ s, and detect a single event as short as 5 ns. As the interference was undetectable with a standard swept-tuned spectrum analyzer, the real-time option offered the best possibility to find the interference source.

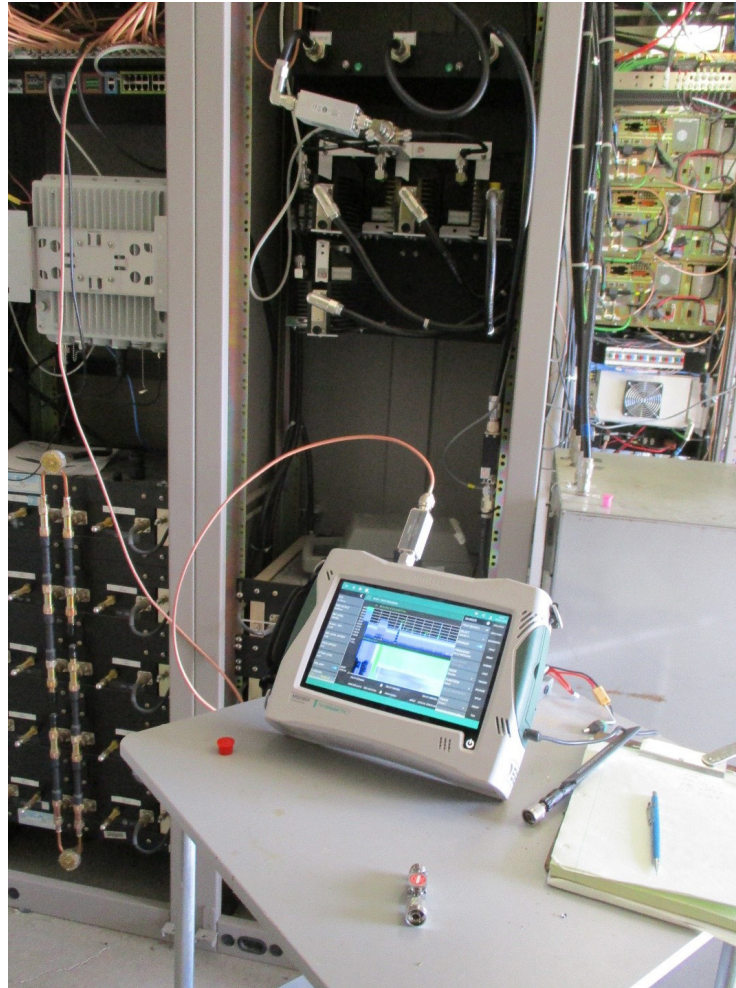
Figure 4. The Field Master Pro MS2090A connected to the P25 system receiver RF test port with the high-pass filter in line.

- Next, the Field Master Pro MS2090A was connected to the system receiver test port with a 800 MHz bandpass filter plus the high-pass filter to further isolate the P25 signal. This allowed the analyzer have the same sensitivity as the P25 receive system (Figure 4).

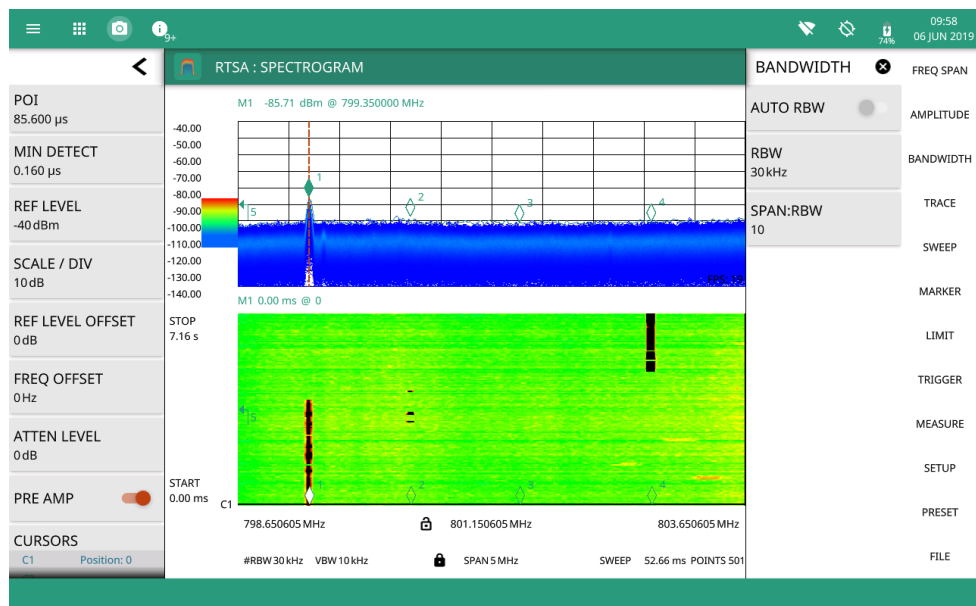
Figure 5. When no interference was present, the activation of P25 traffic is clearly seen as dark lines in the spectrogram.

- The Field Master Pro MS2090A was put into RTSA mode and markers were set on the system's 4 receive frequencies. This verified that incoming traffic could be seen. Initially in RTSA mode, both real-time and spectrogram views were used to try to catch brief interfering signals. This facilitated monitoring for correlation between wanted signal traffic and potential interfering products. (Figure 5)

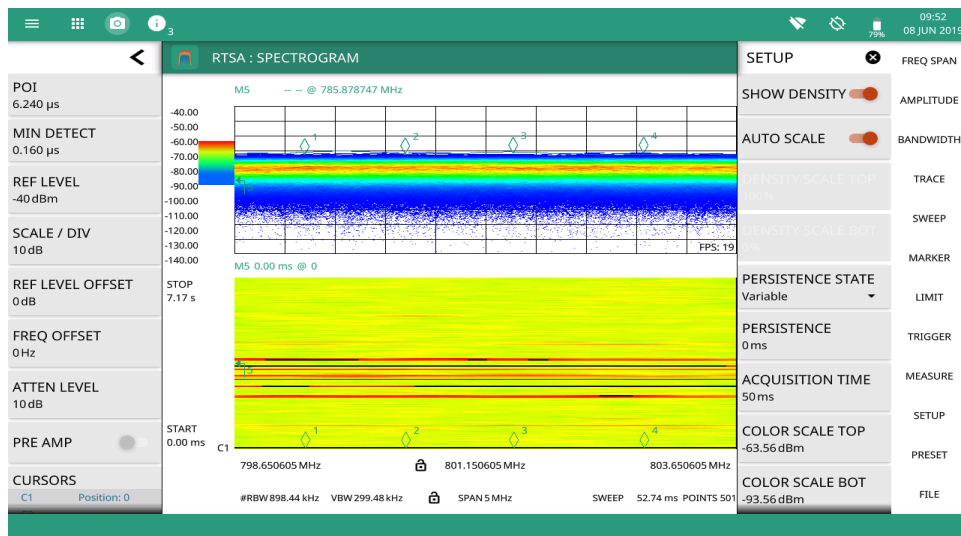
Figure 6. The dark horizontal lines in the spectrogram trace highlight short bursts of high interference signals that covered the full P25 frequency plan. These interfering signals had a power level in excess of -60 dBm, greater than the wanted P25 signals.

- Occasionally, the entire noise floor would jump up to -60 dBm, above the incoming P25 signal level. This was captured as dark horizontal lines in the spectrogram trace that covered the full P25 spectrum. The Field Master Pro MS2090A has a probability of intercept as low as 2.05 μs so that even these very short duration bursts of interference were captured. (Figure 6)

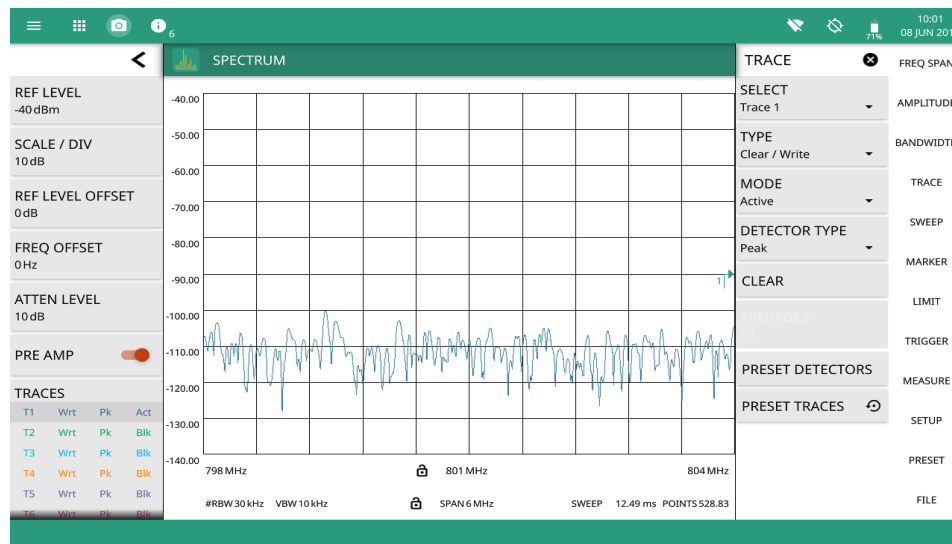
Figure 7. This shows the analyzer noise floor when no interference was present. The sensitivity of -110 dBm is in line with typical P25 radios performance.

- The Field Master Pro MS2090A was switched to standard spectrum analyzer mode to capture traces with and without interference to understand the level of the increasing noise floor.

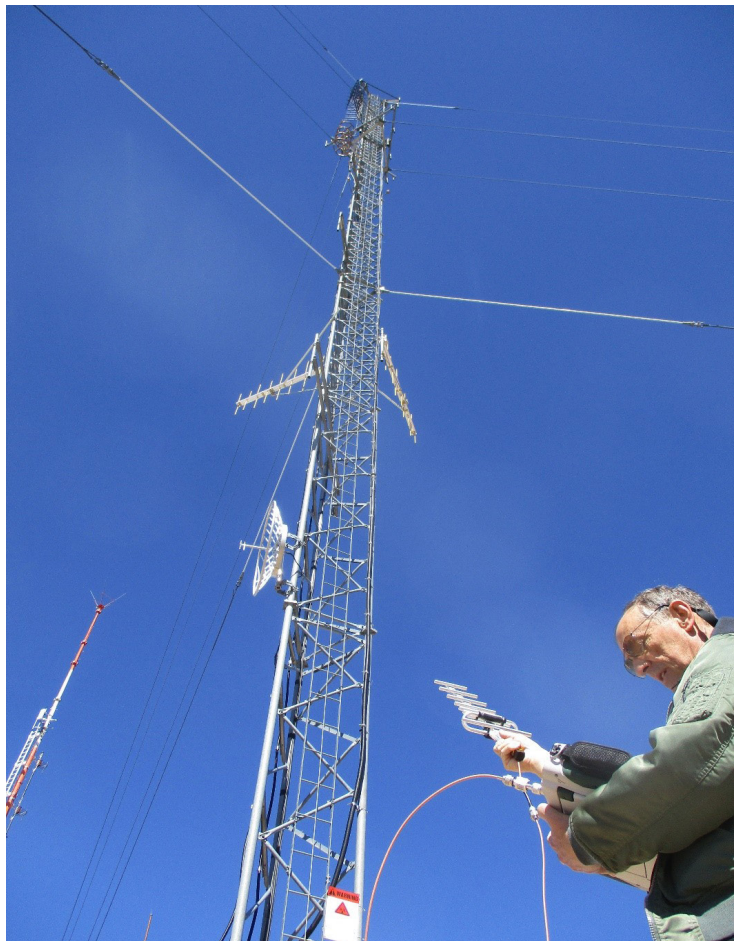
Figure 9. Using a Yagi antenna to search for the source of the intermittent interference.

- Since it was established that there was interference onsite, a directional antenna was attached to the Field Master Pro MS2090A in order to walk the site to hone in on the exact source of interference. Often log periodic antennas are used for direction finding as they offer wide frequency coverage. However, the directional pattern is a compromise compared to Yagi antennas. Direction finding antennas may need to have a low PIM specification to prevent the antennas from generating interfering signals on their own from the very high RF fields present at broadcast sites.

- When direction finding, it is best to start with the antenna aimed towards the ground to see the spectrum display with little interference, then bring the antenna to horizontal and slowly rotate 360 degrees. Rotate the antenna from vertical to horizontal to see if there is a peak in the polarization. In this case, the signal peaked when aimed at a broadcast tower and it was not polarization sensitive. There were, however, numerous metal buildings in the area and it needed to be confirmed that the direction was not from a reflection. Walking around the tower at a 30 meter distance, the direction finding was repeated. In all cases, the interference maximum was with the antenna pointed towards the tower, and levels increased further when the antenna was aimed toward the top of the tower.

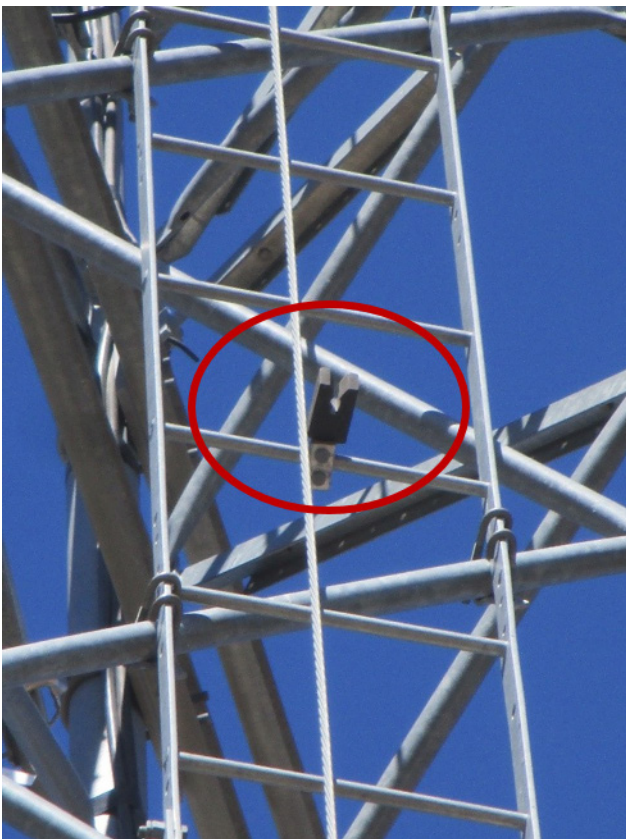
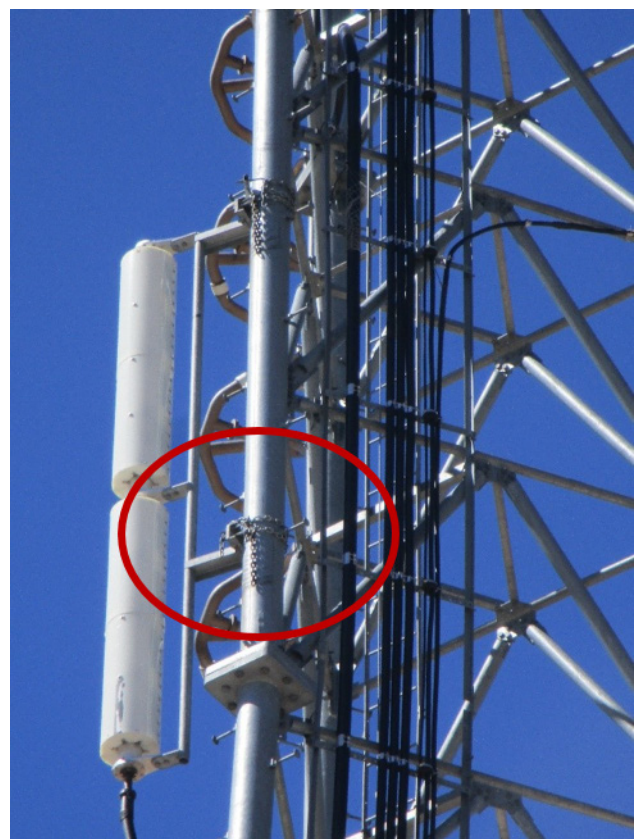
- Using this technique, the noise interference was determined to come from a broadcast tower located 50 meters from the P25 antennas. This mountain-top tower supported a number of broadcast transmitters with numerous antennas so the RF fields close to the tower were very high up. After experiencing significant winter weather, it was discovered that a safety climbing cable running from the ground to the very top of the tower had broken away from its insulated mounts. With high wind, this caused the cable to bang up against the tower causing passive intermodulation (PIM) and set off alarms in the P25 receiver monitoring system. It is well documented that incidental contact by movement between dissimilar metal conductors that are physically and electrically close to transmitter antennas and high RF fields will result in passive intermodulation (PIM) products and cause erratic impulse noise on receivers near the site.

Figure 10. The safety climbing cable, shown having broken free from its isolating tower mount (left) and the loose metal chain (right) were both causes of PIM when being blown against the tower structure by wind.

During a return visit to the site at a later date, when there was no wind, it was noted that there were no alarms triggered in the P25 monitoring system.

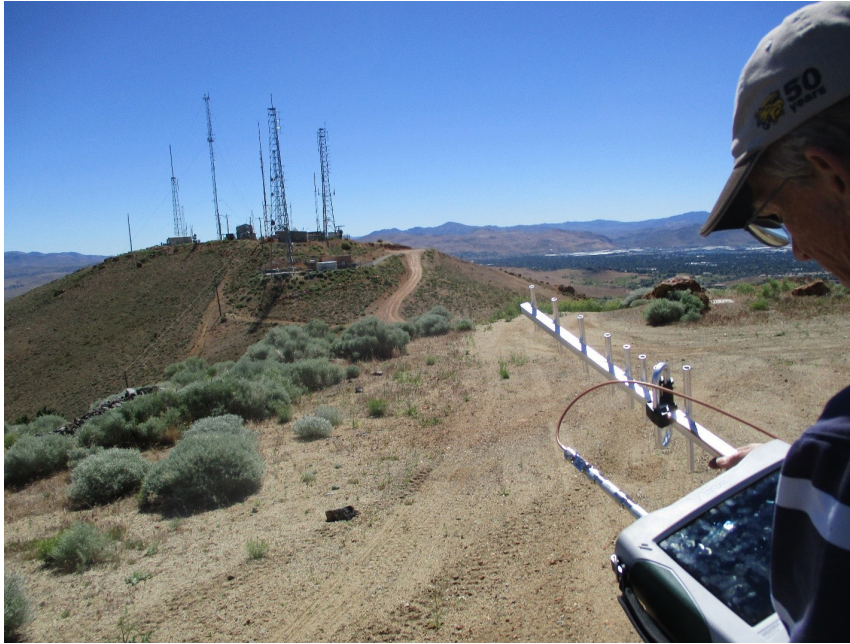
Figure 11. Revalidating the source of the interference from a distant location.

When hunting for interference, reflections from buildings and vehicles can cause multipath and erroneous direction readings. It is best to take direction readings from a number of vantage points to be sure of the source of the interference. There were two hill tops at this site. When retesting from a hill top 1 kilometer away from the shared P25 and broadcast tower site the only interference source came from the direction of the P25 and broadcast site, providing further evidence that the true cause of the interference had been identified.
