# Technical Note

Vol.13  
2020/12

## Tips for Effective Use of Checkweigher: A Zero-Set Error

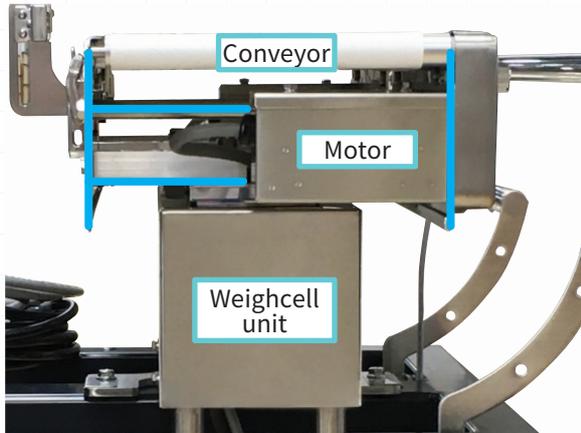
Fig.1 Non-waterproofed weighcell conveyor section

Along with the weighcell unit, the weighcell conveyor section consists of a conveyor, a motor, and a stand (blue line). Since they are placed directly to the weighcell unit, any load from outside can deviate a zero point and lead to a zero-set error.

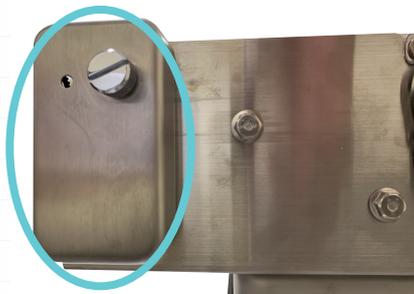
**Causing factor 3** Unexpectedly it is not well known that zero-set error occurs when the user forgets to attach main parts including optional parts. For instance, after the end of production, a user removes a drive belt cover, a product guide, and a cross plate for cleaning and forgets to attach one of them. The load applied to a weighcell becomes lighter and the indicated value on a screen shows at a minus side. In particular, users forget to attach a drive belt cover. Starting the conveyor with a missing machine part can generate a zero-set error.

Fig.7 With a drive belt cover

Please make sure that all parts of the weighcell conveyor unit are attached. After the end of checking, press the zero-set button.

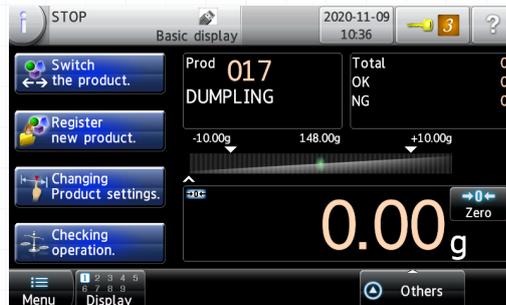
Fig.8 Normal zero point

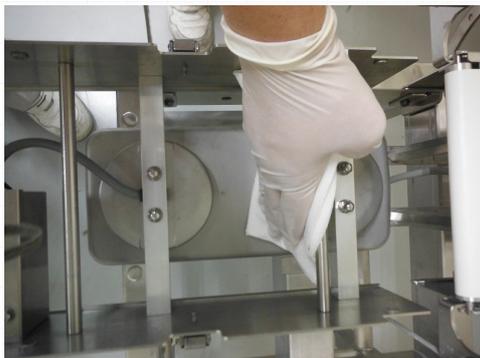
Fig.15 Cleaning weighcell unit

Air blowing is one way of removing dust and food residue; however, they can sneak into the gap in the blind area. We recommend using a cloth for cleaning.

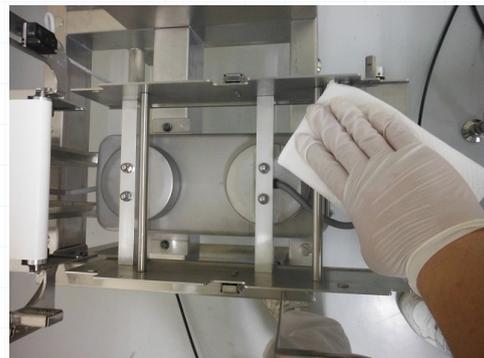
Fig.16 Remove a conveyor to clean a stand

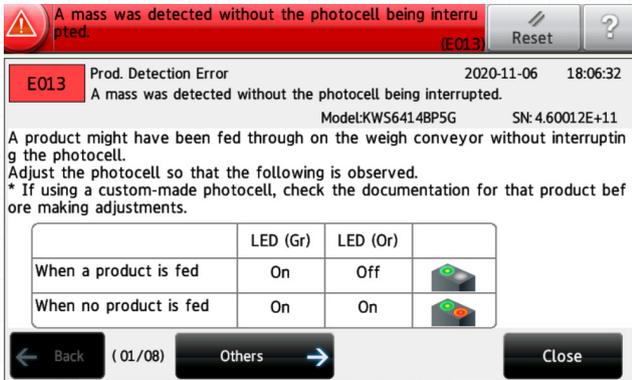
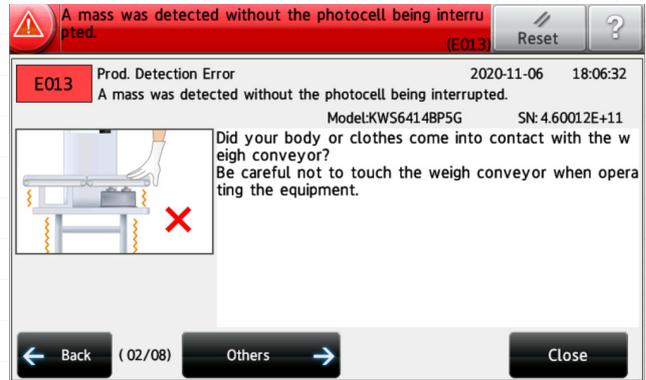
Anritsu SSV Series Checkweighers provide error messaging and on-screen suggestions when an error occurs.

By pressing the "?" button on the upper right-hand corner on the screen, the possible cause and specific guidance are displayed on the screen. Please check guidance when an error occurs. When the problem or error cannot be solved, please contact our support center.
