# Technical Note

## Tips for Effective Use of Checkweigher: A Zero-Set Error

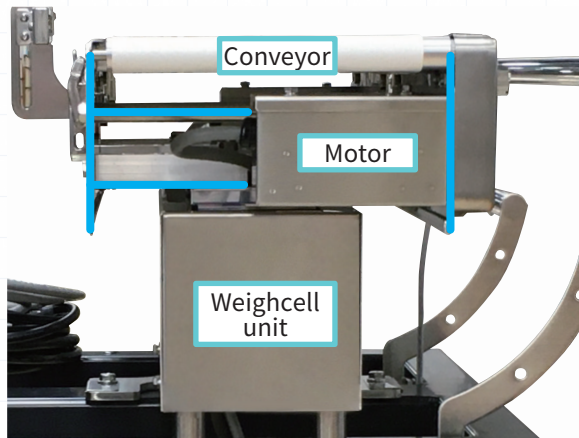
Along with the weighcell unit, the weighcell conveyor section consists of a conveyor, a motor, and a stand (blue line). Since they are placed directly to the weighcell unit, any load from outside can deviate a zero point and lead to a zero-set error.

Fig.1 Non-waterproofed weighcell conveyor section

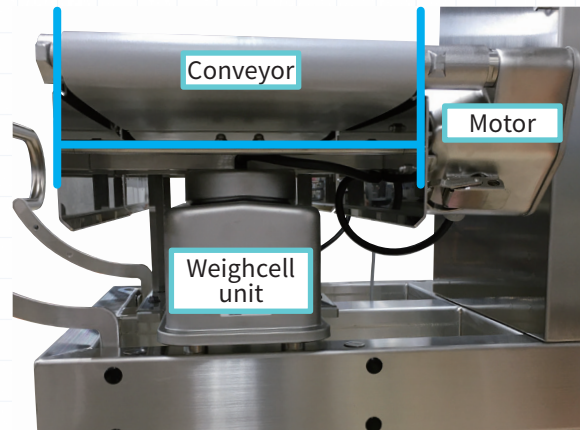
Fig.2 Waterproofed weighcell conveyor section

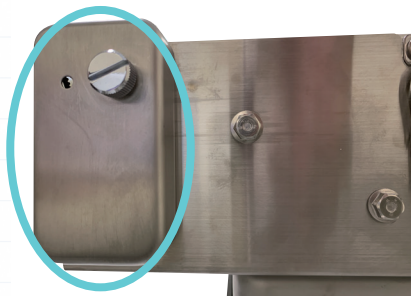
**Causing factor 3** Unexpectedly it is not well known that zero-set error occurs when the user forgets to attach main parts including optional parts. For instance, after the end of production, a user removes a drive belt cover, a product guide, and a cross plate for cleaning and forgets to attach one of them. The load applied to a weighcell becomes lighter and the indicated value on a screen shows at a minus side. In particular, users forget to attach a drive belt cover. Starting the conveyor with a missing machine part can generate a zero-set error.

Fig.7 With a drive belt cover

Please make sure that all parts of the weighcell conveyor unit are attached. After the end of checking, press the zero-set button.

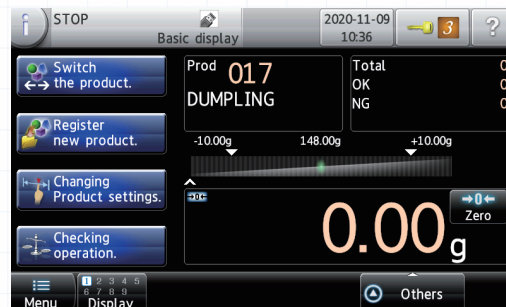
Fig.8 Normal zero point

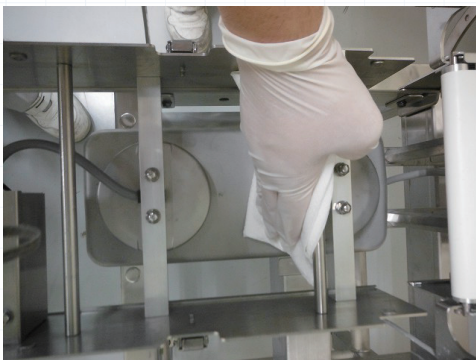
Fig.15 Cleaning weighcell unit

Air blowing is one way of removing dust and food residue; however, they can sneak into the gap in the blind area. We recommend using a cloth for cleaning.

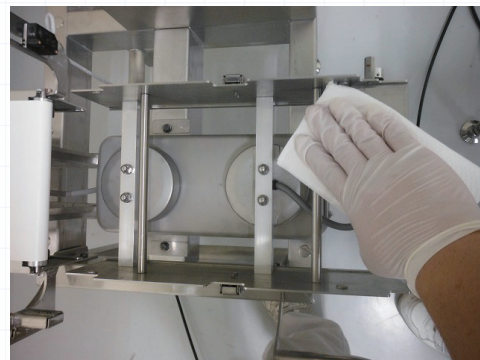
Fig.16 Remove a conveyor to clean a stand
