The verification technology for the quality and reliability of parts

Kiyoharu Akimoto, Shinji Koyama

This article describes some effective solutions for increasing quality using structural analysis and inspection of parts.

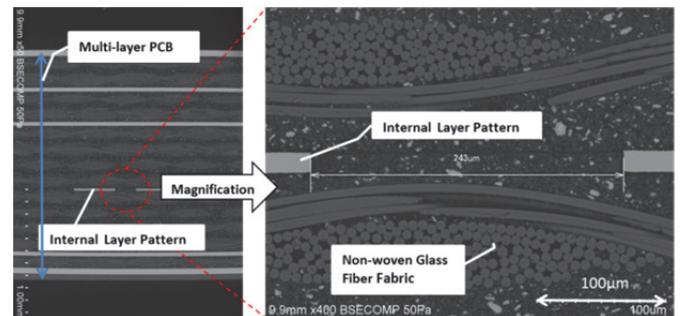
Figure 7 Cross Section of Multi-layer PC Board

Figure 7 shows the cross-section of a multi-layer PC board. This cross-sectioning process can be used to determine whether the dimensional accuracy between the multi-layer PC board patterns satisfies the design criteria. It can also be used to evaluate deviations from the design values, and plating quality by providing details of the internal board structure.

The cross-sectional analysis is required when creating a new PC board design or using a special layer configuration. It is used in cooperation with the PC board manufacturers to assure product reliability and quality.

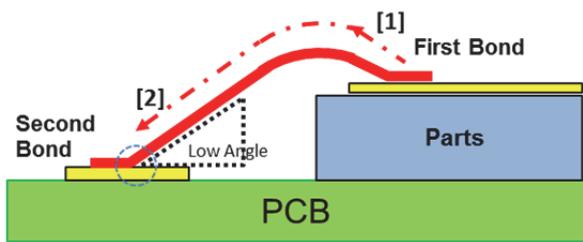
Figure 10 Schematic of Good Lot

As shown in Figure 10, in a good process, the angle of the second bond is low helping minimize the tensile stress.

Wire Bonding Procedure (After Improve)

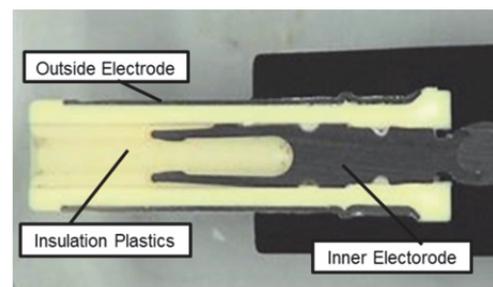
Figure 17 DC Plug Internal Structure

Insulation plastics include red phosphorus, which can cause insulation aging. When the insulation plastic of DC plugs of AC adapters ages, there is a high risk of shorting between the external and internal electrodes, which may cause a fire. Figure 17 shows the internal structure of these plugs.

An EDX analysis can provide information about the presence of red phosphorus. The results of the following EDX analysis for red phosphorus (Table 4) in the insulation materials of a connector show that no phosphorus (P) is present.
