Anritsu - GRL

PCIe 3.0 CEM Rx Test Application

Release Note

Third Edition

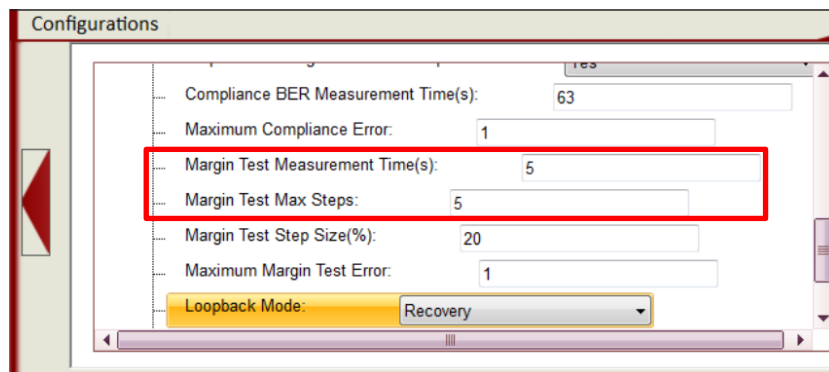
Decrease **Margin Test Measurement Time** and **Margin Test Max Steps**.

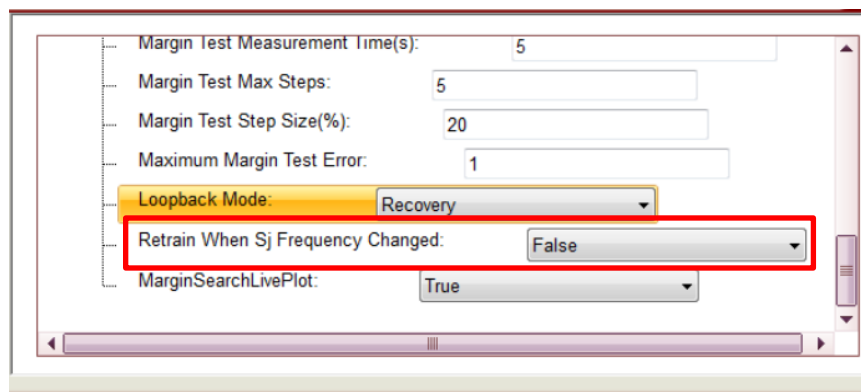
Set **Retrain When Sj Frequency Changed** to **False**.

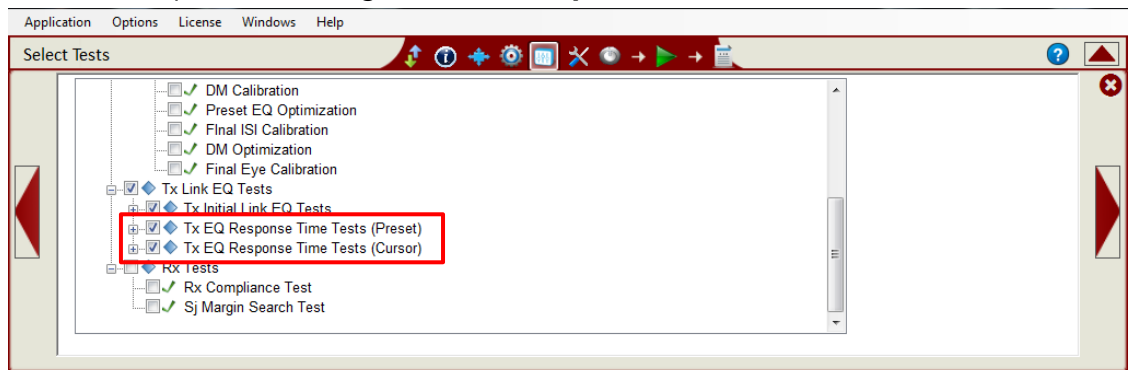
Perform a test with **Tx EQ Response time (Preset)** first and then perform it with **Tx EQ Response Time (Cursor)**.

When starting the test with **Tx EQ Response Time (Preset)**, the cursor values corresponding to Preset are notified from a DUT, and they are saved in MP1900A. These values are required for testing with **Tx EQ Response Time (Cursor)**.

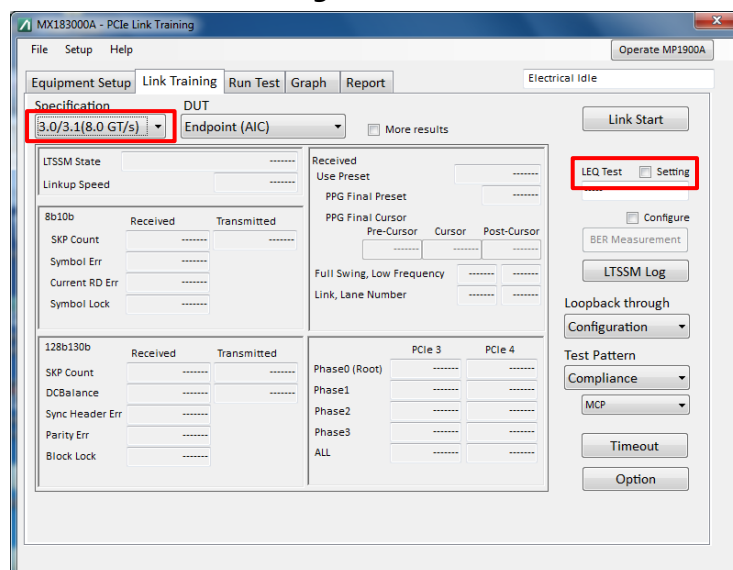
- Launch MX183000A with PCIe Link Training application.
- Initialize the PCIe Link Training application.
- Set **Specification** to **3.0(8.0 GT/s)**.
- Click on **LEQ Test Setting** check box.

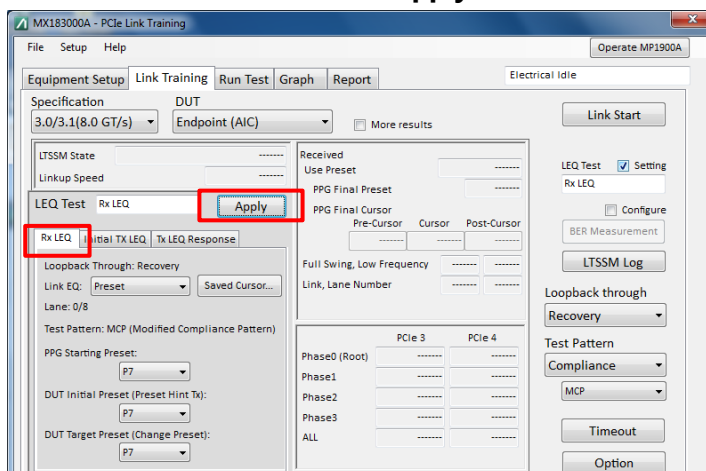
- e. Select **Rx LEQ** tab and click on **Apply** button.

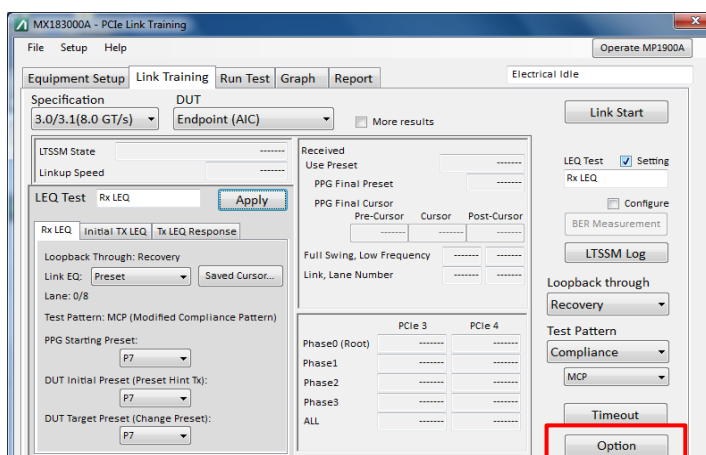
- f. Click on **Option** button.

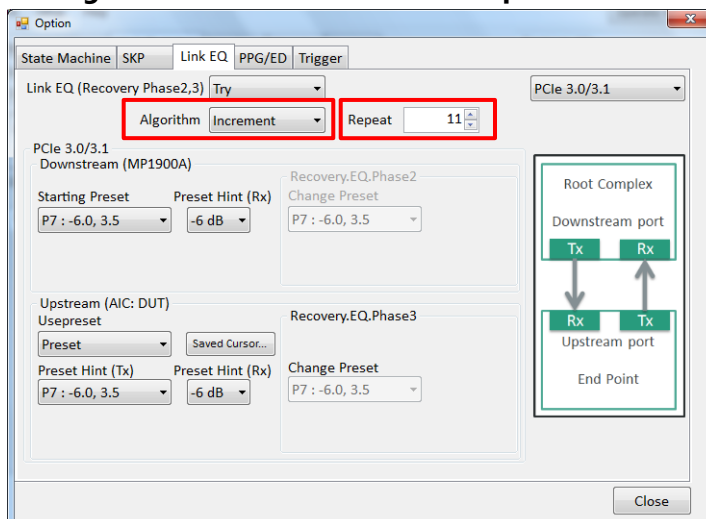
- g. Set **Algorithm** to **increment** and set **Repeat** to **11** on **Link EQ** tab.

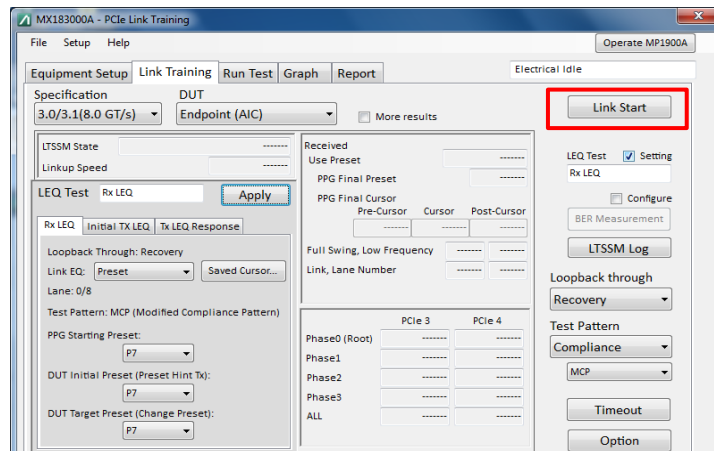
- h. Reset a DUT and click on **Link Start** button.

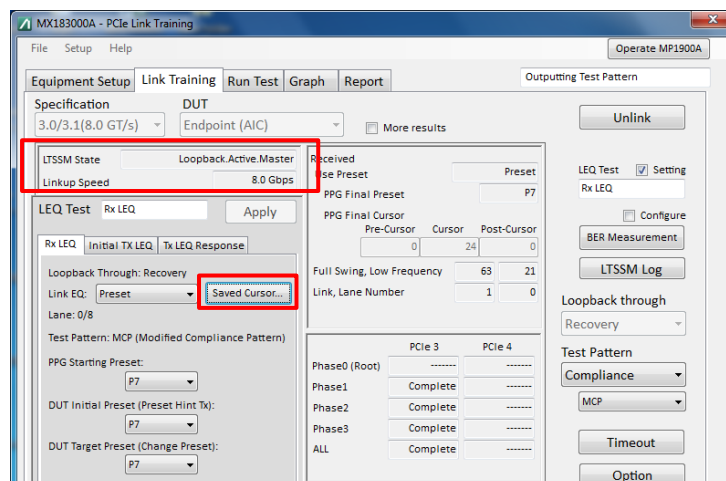
- i. When **LTSSM State** is **Loopback.Active.Master**, click on **Saved Cursor** button on LEQ Test window.

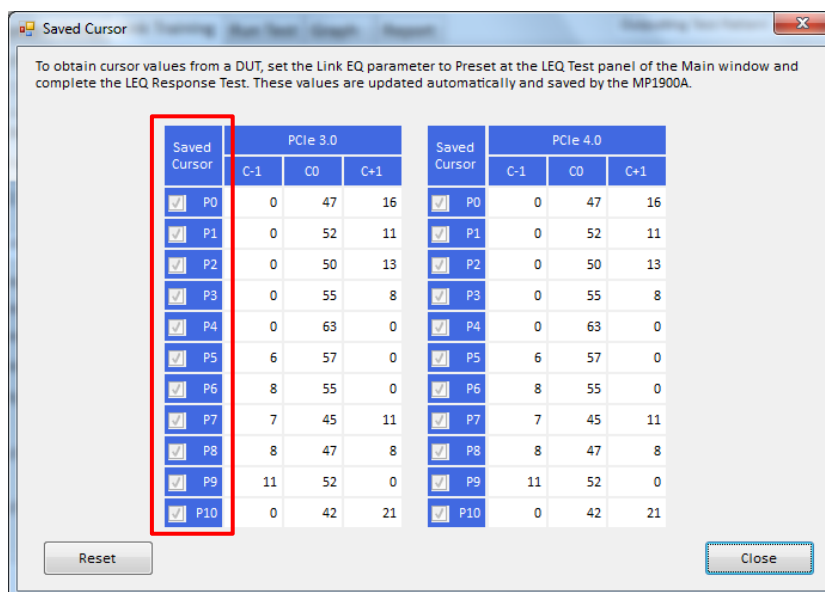
- j. If All **Saved Cursor check boxes** are **ON**, the steps are finished.

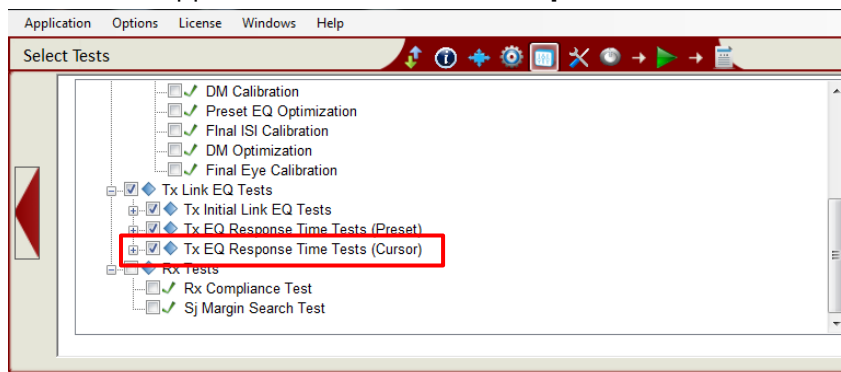
- k. Launch GRL application and start **Tx EQ Response time (Cursor)**.

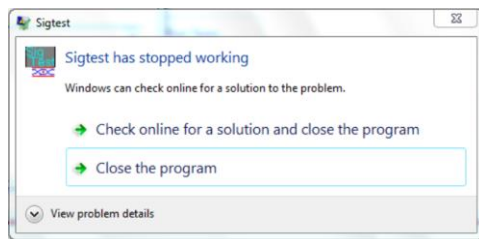
A SigTest error message is displayed and SigTest has stopped working when calibrating SJ, RJ and EH/EW. Since this message is no effect on calibration results, click **Close the program** to continue the calibration.

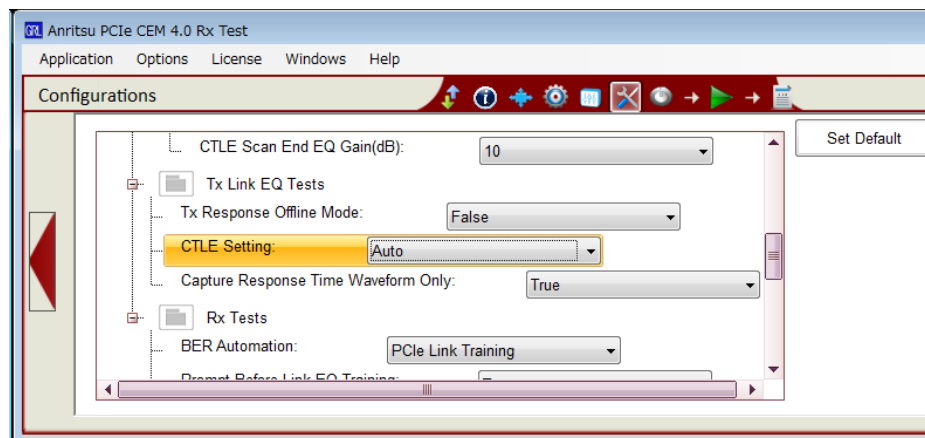
- On the **Configurations** tab, set **CTLE Setting** to **Auto**.

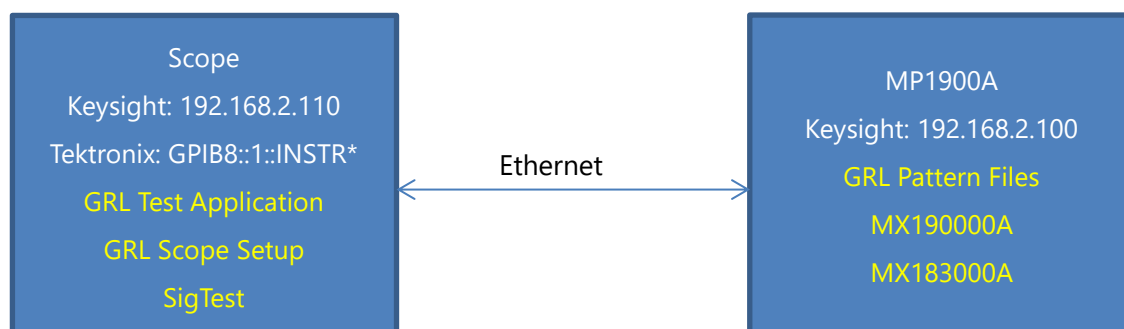
- Recommended connection

1. Connect instruments with Ethernet cables as shown below.
2. Set the IP and GPIB addresses as shown below. These can be set in the Network and Sharing Center (Windows OS feature).
3. Install all applications as shown below (Yellow letters).

- * TCP/IP cannot be used when the GRL software is installed on a Tektronix scope. Set the GPIB address as "GPIB8::1::INSTR".

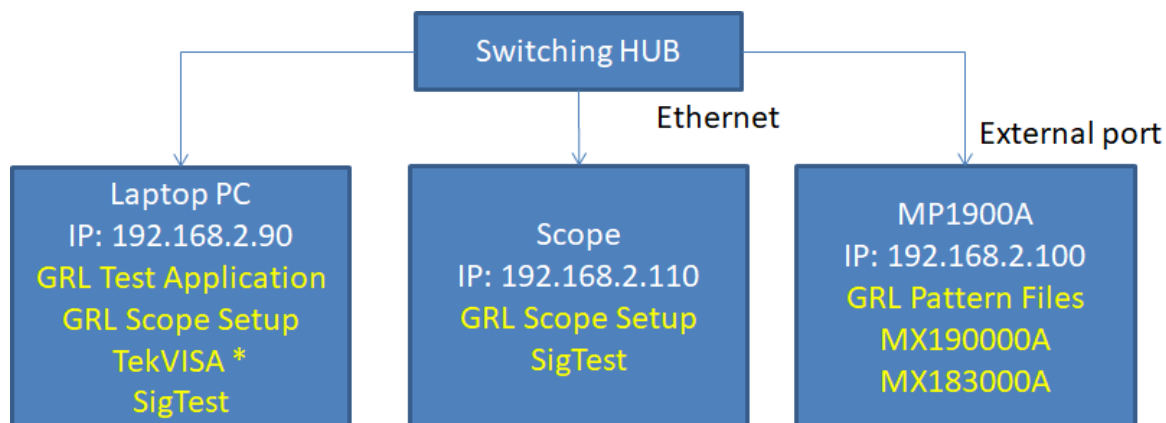
- Optional connection

- * TekVISA is needed to control Tektronix scopes. But, the PC on which TekVISA is installed cannot control Keysight scopes. Also, this configuration makes the remote control speed slower than the recommended configuration.

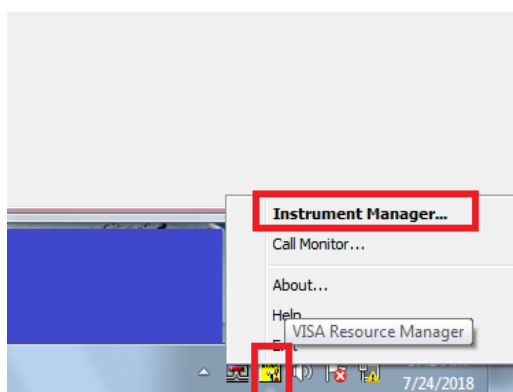
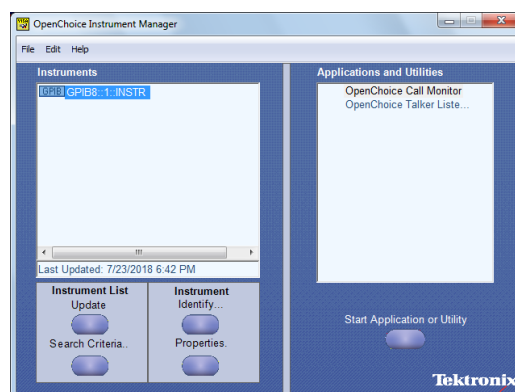
Tektronix Scope

When the GRL software is installed on the laptop: TCPIP0::192.168.2.110::inst0::INSTR

When the GRL software is installed on the scope: GPIBX::1::INSTR*

*Tektronix scope cannot use TCP/IP when the GRL software is installed on it. In this case, GPIB VISA should be set. The address can be checked using the VISA instruments Manager.

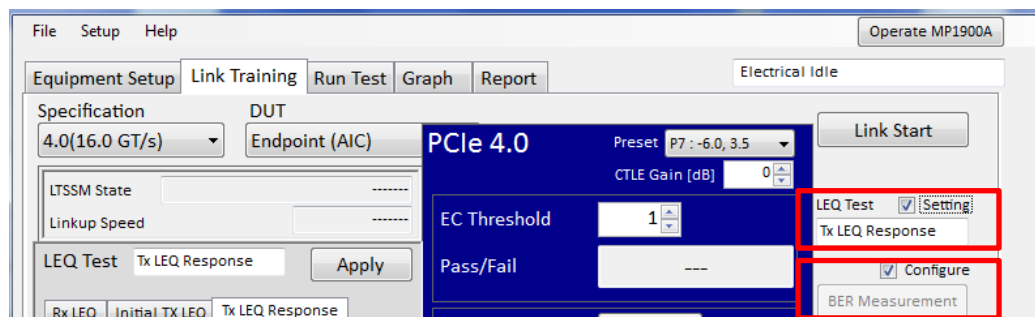
- a. In MX183000A, display the LEQ test settings and BER Measurement screen.

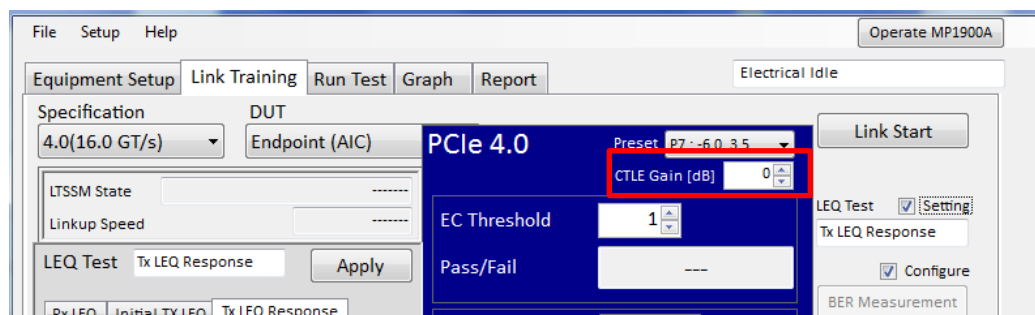
- b. Set **CTLE Gain** to **0** (zero) on the BER Measurement panel.

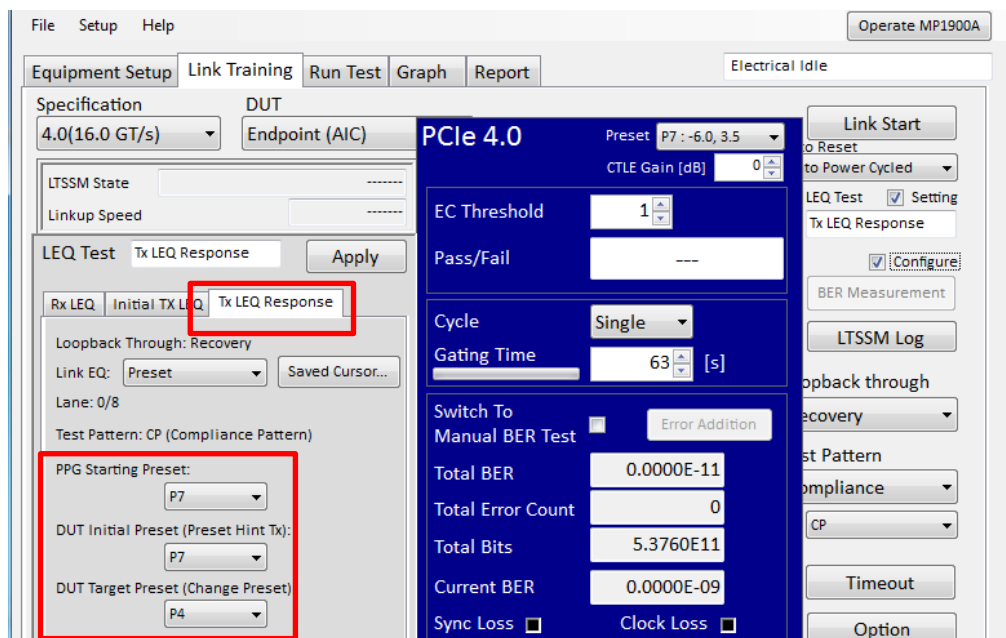
- d. On the **Tx LEQ Response** tab of the LEQ test pane, set **PPG Starting Preset** to **7**, **DUT Initial Preset** to **7** and **Target Preset** to **P4**.
