# Application of Machine Learning to Printed Circuit Board External Inspection

[Summary]

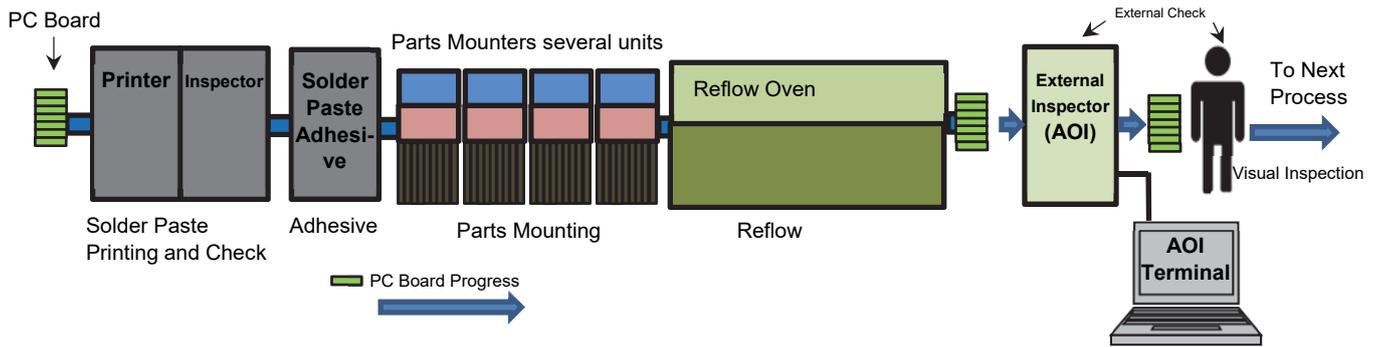
Figure 1 Example of SMT Line

At manufacturing of general-purpose surface-mount PC boards, solder paste<sup>Note 1</sup> is applied to the PC board using a liquid presoldering method. As shown in Figure 1, using the pre-soldering method, first, solder paste is painted onto the board surface through a stencil-like metal mask<sup>Note 2</sup> (Solder Paste Printing). This is followed by application of an adhesive to prevent parts falling off during mounting and then by mounting of parts on the board surface. Next, the pasted board populated with parts passes through the reflow process to melt and solidify the solder paste and secure the

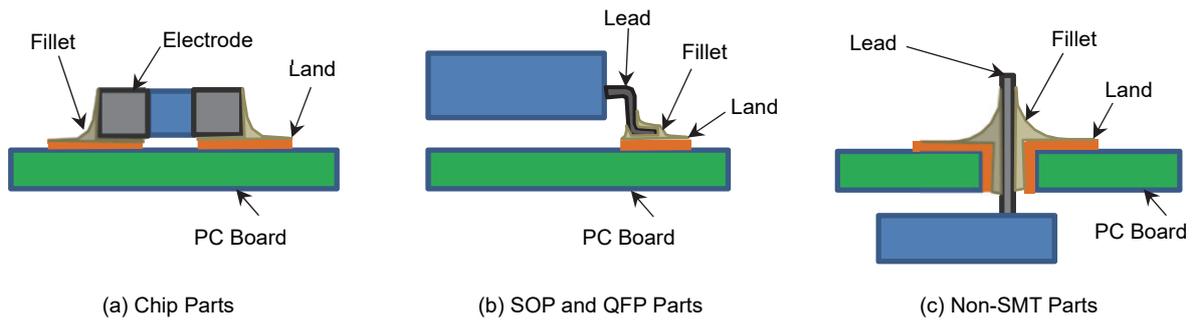
Figure 2 Examples of Normal Fillet Shapes

When parts are mounted correctly, the part lead or electrode is soldered cleanly to the land on the PC board<sup>Note 3</sup> and the external appearance of the joint is a smoothly curved meniscus. This is described as a fillet. In addition, the joint surface is "flowing" and "wets" the connected elements. Figure 2 shows some examples of correct fillet shapes for solder joints.

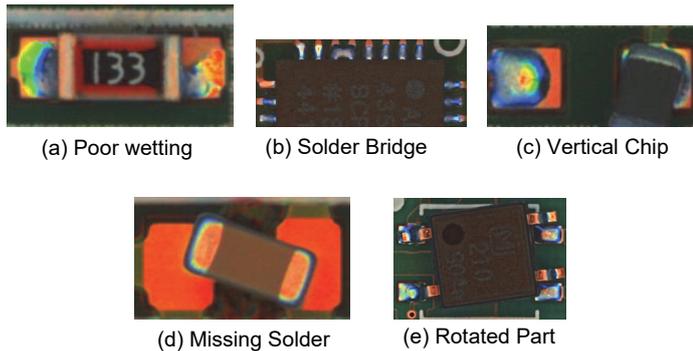
Figure 3 Examples of SMT Mounting Faults

If there are any problems with applied solder paste amount or position, position of mounted parts, or with the reflow temperature management, the fillet shape may be deformed, resulting in a poor solder joint between the part and board. See reference 5 for details of the causes of various types of poor SMT joints. Some typical examples are listed below and shown in Figure 3.

The solder is not spread evenly in the correct amount over the part leads and electrodes and the fillet form does not appear wetted. The causes are insufficient solder, leads or electrodes not in contact with land, and insufficient heat at reflow.

This problem tends to occur when using very small SOP and QFP ICs with sizes of 0.5 mm and 0.4 mm<sup>Note 4</sup> or when the correct amount of solder is not applied to adjacent leads. The causes are poor solder printing, bent solder leads, and poor parts mounting.

This problem occurs when both electrodes of a part are not soldered simultaneously and surface tension at the end wetted first causes the chip to stand vertically on one soldered electrode.

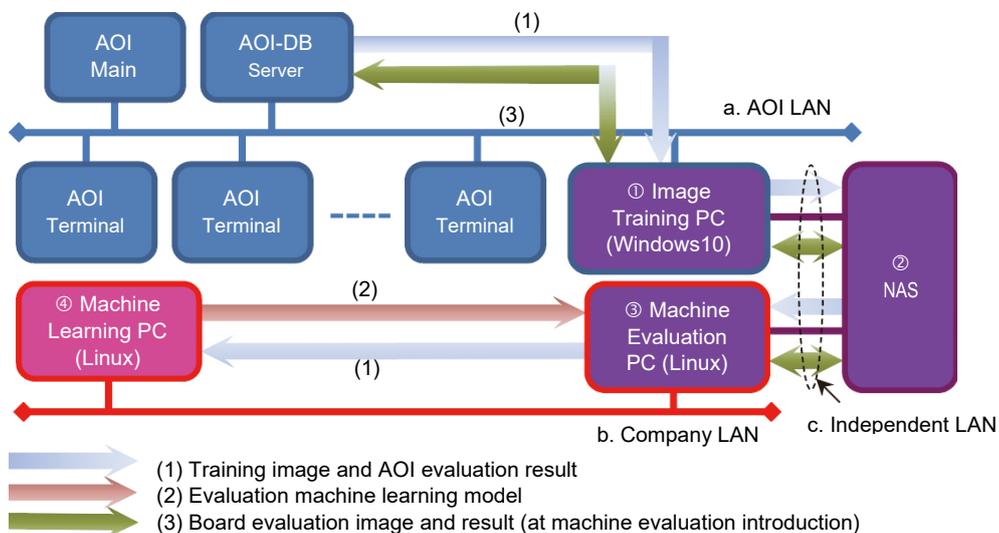
Figure 4 Image Acquisition System Configuration

Collecting and annotating (labeling) images used for machine learning is a key process in applying machine learning. Consequently, we configured a system (Figure 4) to capture AOI inspection image data for use as learning images.

To assure the independence of the AOI LAN, the machine-learning environment (③ and ④ in Figure 4) was configured on the in-company LAN via a separate independent LAN (c. Independent LAN in Figure 4) and multiport Network Attached Storage (NAS) (② in Figure 4).

This software was run on one Image Training PC on the AOI LAN (Figure 4).

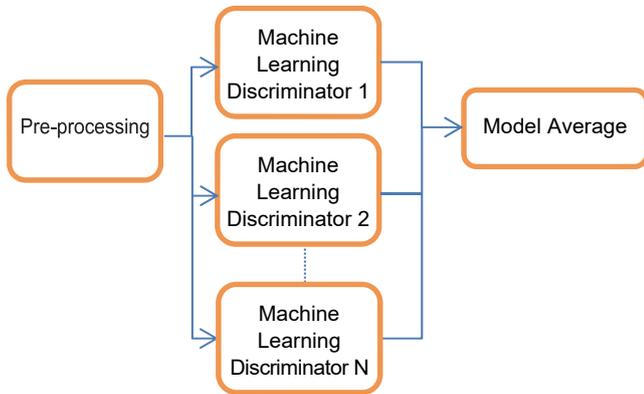
Figure 6 Model Averaging

As shown in Figure 6, this inspection uses multiple discriminators and evaluation is performed using the model average, which averages the output of each discriminator. Better performance can be expected<sup>1), 2)</sup> with suppressed randomness, etc., by changing the learning parameter default values and combining multiple discriminators than when using a single discriminator.

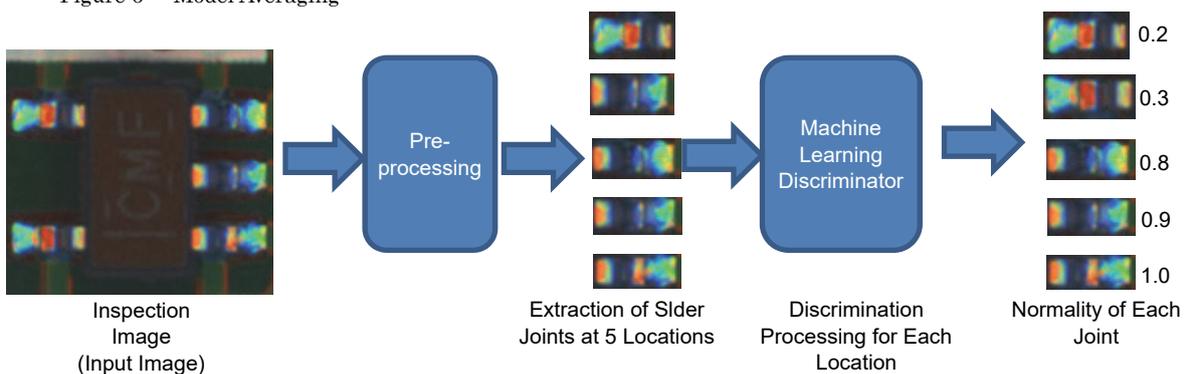
Figure 5 Discrimination Procedure using Machine Learning

Figure 5 illustrates the discrimination procedure. First, pre-processing loads the image to be inspected and identifies the solder locations. The solder locations identified by the discriminator are output as numeric discrimination results in the range of 0.0 to 1.0 indicating the normality distribution of the solder locations, with a value of 1.0 being maximum normality. The normality threshold value determines whether the solder joint condition is pass or fail.

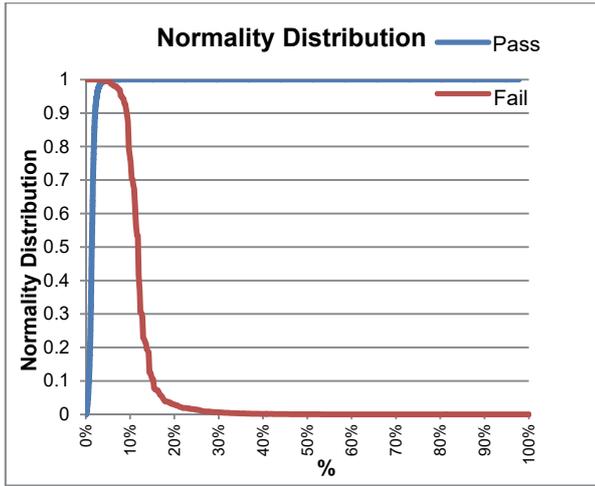
Figure 7 Normal Board Distribution

Figure 7 shows the cumulative distribution confirming the normality distribution. The red line is the cumulative distribution of normality for fail parts (493 locations) and the blue line is the cumulative distribution of normality for pass parts (65,168 locations). The fail parts cumulative distribution origin is 1.0, but is best if distributed in the lower half with the origin at less than 0.5. In addition, the pass parts cumulative distribution is the distribution with 0.0 as the origin, but is best if distributed in the upper half with the origin at more than 0.5. Since the cumulative distributions for the pass and fail locations intersect, evaluation mistakes occur when evaluating using a threshold.

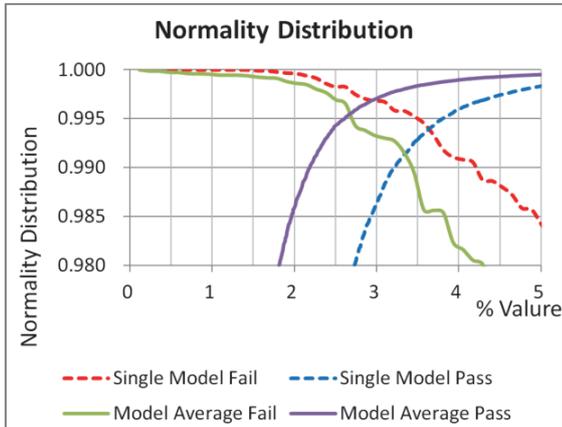
Figure 8 Comparison of Model Average and Single Model Normal Board Distribution

Figure 8 shows a comparison of the normality for the model average and single model results. The value for pass locations increases by using the model average compared to not using it, and the normality improves because the value for fail locations decreases. However, evaluation mistakes occur when using the evaluation threshold due to the distribution intersection.

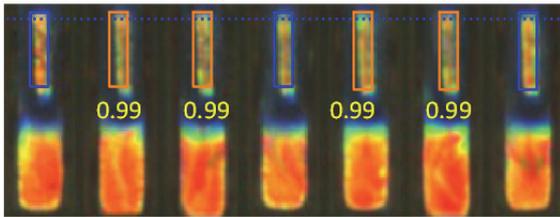
Figure 10 Example of Correct Answer  
(Fail Detection at Excess Watching)

To confirm the mis-detection phenomenon, actual images were checked. Figures 9 to 11 show examples of fail results using machine learning. For AOI-evaluated fault locations, on-site visual inspections were performed by a specialist and the results were compared with the machine-learning results. In these figures, locations evaluated as pass by AOI are enclosed in a blue frame, while those evaluated by AOI as fail are enclosed in an orange frame; locations evaluated as fail by both AOI and visual inspection are enclosed in a pink frame. The numerical values in Figures 10 and 11 indicate the normality output by machine learning. The orange-frame locations in Figure 10 were evaluated as fail by AOI but pass by visual inspection. We clearly see the high numeric value of the results assigned by machine learning to these orange locations. Additionally, the pink frames in Figure 11 which were evaluated as fail locations by both AOI and visual inspection, were assigned low numeric values by machine learning. The machine-learning normality output is extremely close to the results of visual evaluation by a specialist.

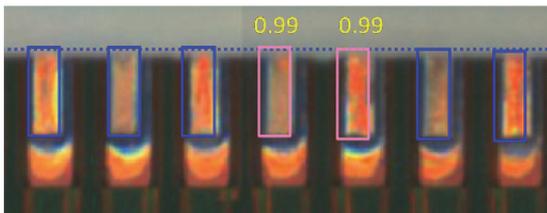
Figure 12 Example of Mis-detection (Missed Fail Location)

Figure 12 shows examples of images where the machine-learning evaluation results was incorrect (fail location evaluated by machine learning as pass). In these cases, fail locations (in pink frame) were assigned a high normality value by machine learning. It seems it is difficult to detect some fails just from the image since the image color distribution is not unlike a pass location. Additional information from an inspector seems to enable better evaluation.
