Why do I need to inspect and/or clean the fiber in an optical BBU/RRH link?

Introduction

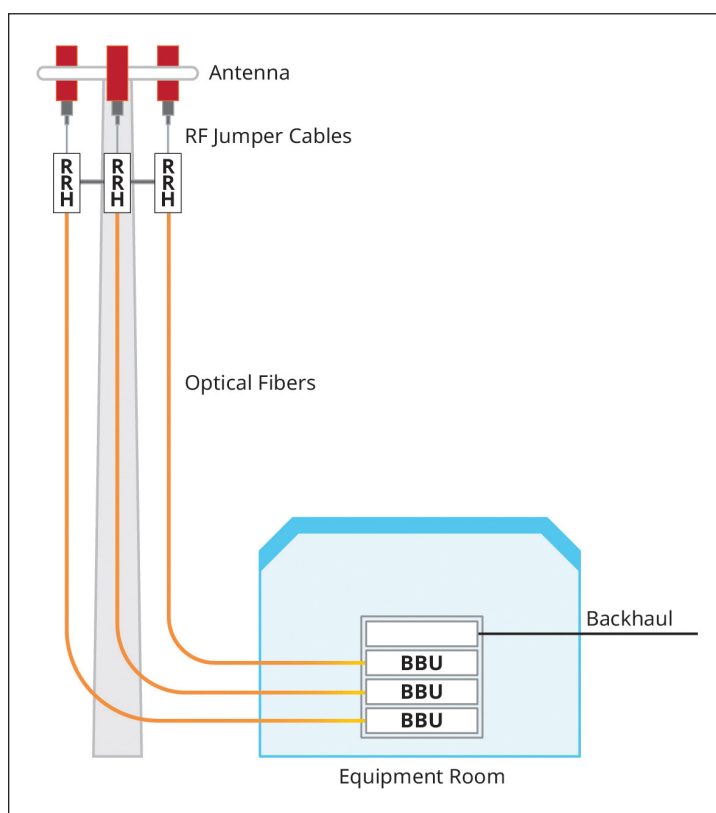
Figure 1: Example of BBU/RRH configuration with optical CPRI link

It has been several years since the initial introduction of the current BBU (Baseband Unit) and RRH (Remote Radio Head) architecture of today's wireless cellular systems. This relatively new architecture incorporates a fiber optic link between the BBU and one or more RRH units, and the data carried through this fiber optic link is typically mapped in a CPRI (Common Public Radio Interface) protocol and in some cases an OBSAI (Open Base Station Architecture Initiative) protocol may be used, however CPRI is more commonly found. Conceptually the architecture is ideal and has very few drawbacks, although in early deployments many problems were encountered with this type of architecture. In the earliest deployments of these systems, many field technicians were not familiar with the new optical interface and simply did not have the required experience to properly install, and/or troubleshoot and resolve the issues on site, which led to the brute force replacement of many early deployed RRH units. There is sufficient evidence supporting the fact that many of these replaced RRH units were determined to have no faults found after being returned to the manufacturer. So what really happened? Replacing the RRH on site seemed to resolve the issue but the manufacturer found no faults with the RRH when it was returned. It is the belief of the author that the fault generally resides within the optical link between the BBU and RRH, and not solely in the RRH itself. In this article we will take a closer look at the actual physical optical link and we will discuss the optical transceiver hardware that is most commonly used in this type of system.

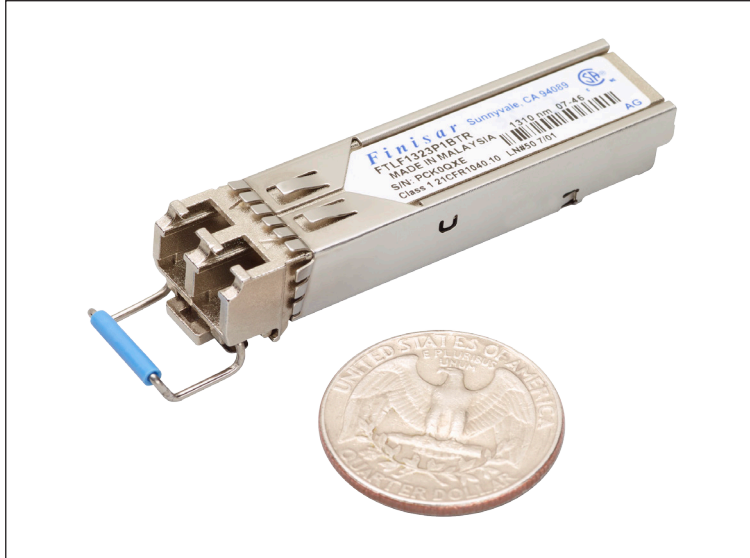
Figure 2: Typical SFP module

Let's start with the optical transceivers used. In the overwhelming majority of these systems, the SFP (Small Form-Factor Pluggable) and/or SFP+ (the plus refers to data rates of 5 Gb/s or higher) module is the optical transceiver of choice, mainly due to its very small size, low cost, and the abundance of pre-existing technology readily available that was originally developed for the optical wireline industry (the fiber optic core backbone). It is easy to understand why the manufacturers of this new wireless system architecture selected SFP modules as the transceiver(s) of choice.

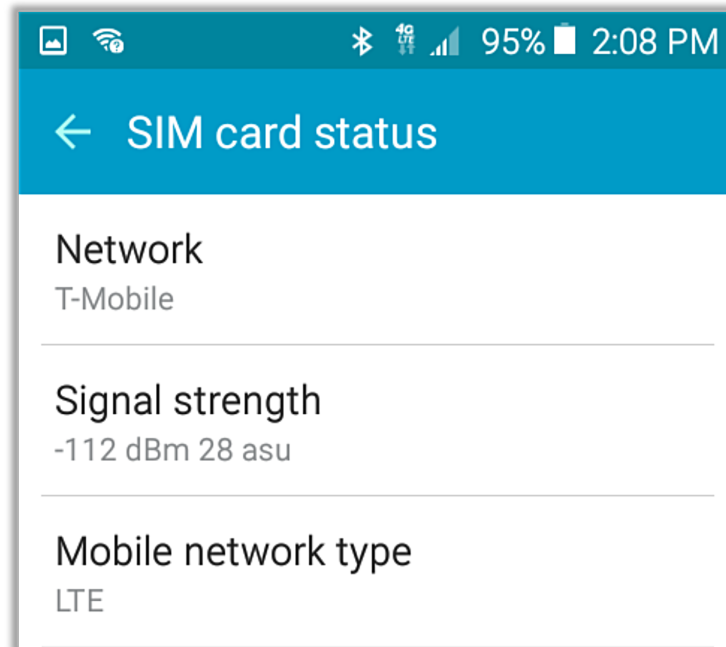
Figure 3: Actual signal strength level as indicated on LTE cell phone. Notice 3 bars out of 5, and -112 dBm

So, if fiber is so great, and has such low loss then why do we care if it's clean? Why do we need to have special fiber inspection scopes and special fiber cleaning kits? Why should we care? The answer mainly lies in the optical receiver technology, and the inherent lack of great sensitivity in optical receivers (which reduces even further as data rates increase) in general, but to further compound that issue is the fact that the SFP is the transceiver of choice in these systems for reasons of low cost, easy deployment, and their availability, and of course their small size. If we take a moment to review a typical RF based receiver, we quickly see that RF receivers can have (and do have) extremely good sensitivity, for example a cell phone has no problem receiving signal strength levels at -100 dBm or lower. The cell phone being used by the author is receiving an LTE signal with a displayed signal strength value of -112 dBm (as reported by the phone itself) and this low level signal received translates itself as 3 out of 5 bars showing on the phone's signal strength indicator at the top of screen.

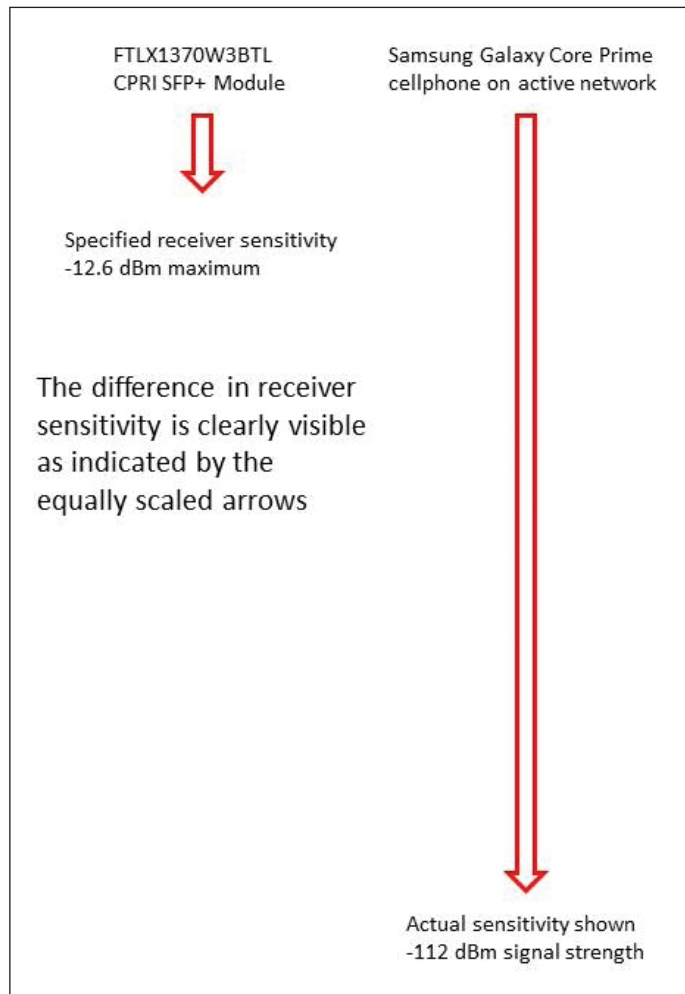
Figure 4: Comparison of typical RF receiver sensitivity vs the SFP+ optical receiver sensitivity

Let's compare that with a SFP+ module specifically designed for CPRI links between the BBU and RRH equipment. We will use Finisar's FTLX1370W3BTL as the optical transceiver for this comparison. This SFP+ module is compatible with 5 CPRI line rates, from 2.457 Gb/s going up to 9.8304 Gb/s. An SFP+ transceiver module is comprised of an optical transmitter and an optical receiver in a very compact package. In the last paragraph we looked at a simple RF receiver's sensitivity and saw that it easily manages to receive LTE signals at -112 dBm (signal strength). Now look at the optical receiver sensitivity on this SFP+ module. It's not -112 dBm, and not -100 dBm, it's not even -50 dBm! The sensitivity is only -12.6 dBm max! Imagine what would happen in the RF world if the typical RF receiver had such poor sensitivity? We'd probably still be using smoke signals to communicate! Could -12.6 dBm be a typo on the datasheet? No, it is correct. So what this really means is that because of the optical receiver's characteristically poor sensitivity, every measure must be taken to ensure that every possible dB of optical signal transmitted actually reaches the receiver. The transmitter optical power specification for this SFP+ module is -5.2 dBm minimum. While it is possible that the actual transmitted power may be higher, -5.2 dBm is the only guaranteed specification therefore the link budget between Tx and Rx (not counting fiber loss) could be as low as 7.4 dB (-5.2 dBm minus -12.6 dBm). RF link budgets are easily 100 dB or more. This is of course a worst case scenario. It is also useful to know that as data rates increase, receiver sensitivity decreases, and the specifications used in this example are applicable to the highest data rate supported by this SFP+ module. Even at lower rates, the link budget for most SFP or SFP+ type modules may typically average about 20 – 25 dB, which is still many orders of magnitude less than what a typical RF link budget of over 100 dB is.

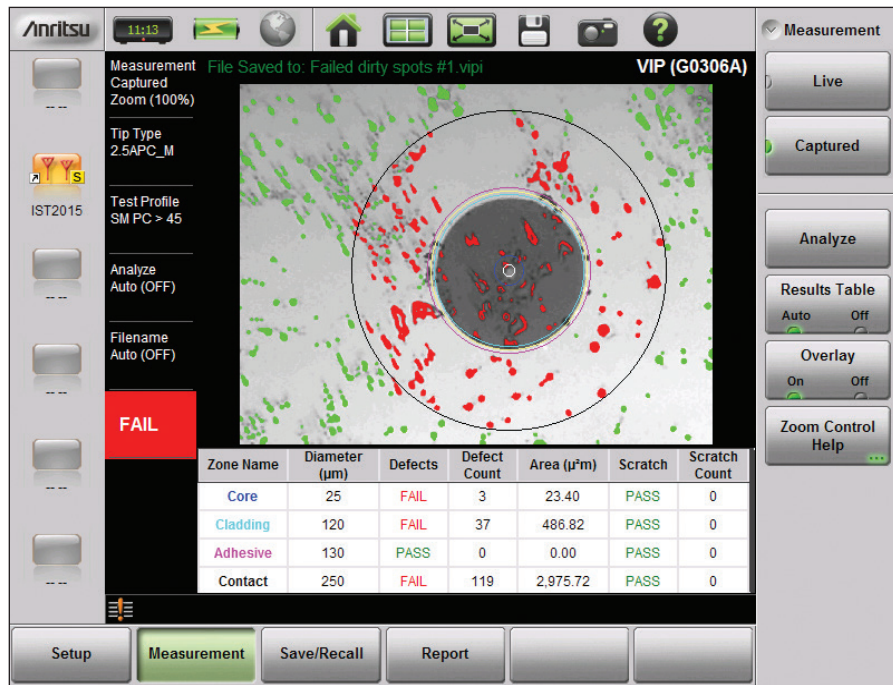
Figure 5: Dirty fiber connector end fails IEC 61300-3-35 standard based test (Oil left on connector end by only one single touch with a bare finger)

One look at the dirty fiber connector end should make you wonder just how much signal may have been lost in that optical link if the fiber had not been properly cleaned. Although it is not possible to accurately predict the amount of loss a dirty connector will have since each case will be unique, it is common to see signal losses caused by a dirty connector often greater than 1 dB, and it is highly dependent on where that dirt is actually located. Going back to the 7.4 dB signal link budget calculated earlier, if we had a 1 dB loss at each end caused by dirty connectors, that is over 25% of the link budget, and surely would cause throughput problems, alarms, or even a non operational condition. If it is anywhere in the region of the 9 μm (SM fiber) or 50/62.5 μm (MM fiber) core of the fiber itself (which is about the diameter of a human hair), then surely the losses will be significant enough to cause either a serious degradation in performance or perhaps a complete loss of operation. If there are dirt particles present on the fiber end, just the simple exercise of disconnecting and reconnecting a fiber could change the status of an operational BBU to RRH link to a non-operational status. If this type of phenomenon is occurring, it's usually a pretty good indicator of dirty fiber(s) and it is best practice to use a proper fiber visual inspection probe (VIP) and perform the IEC 61300-3-35 standard based pass/fail tests after cleaning the suspect fiber(s).

4. Dirty fiber. As seen in figure 5, this accounts for the majority of problems found in these types of systems.

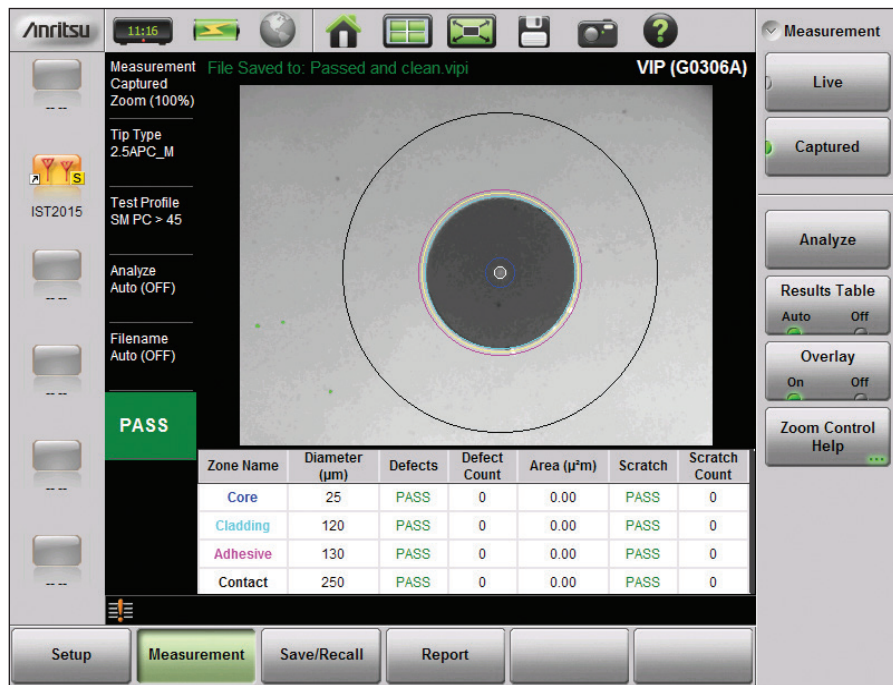
Figure 6: Same fiber connector end after proper cleaning. Now passes the IEC 61300-3-35 standard test easily

By now it should be obvious that there is very little margin for error in regards to signal loss from the transmitter to the receiver in the SFP+ module discussed in this article. So now that we understand the need to ensure clean and damage free fiber ends, it is good to know that there are already industry accepted pass/fail test profiles defined for this purpose such as the IEC 61300-3-35 introduced by the International Electrotechnical Commission (IEC). Instruments supporting this standard can be used to inspect fiber connector ends, and perform pass or fail judgements on the fiber connector ends as per the standard. The results can be archived and included in the reports submitted in the closeout package. On page 5 are some examples of a dirty fiber connector end and the same fiber connector end after proper cleaning.

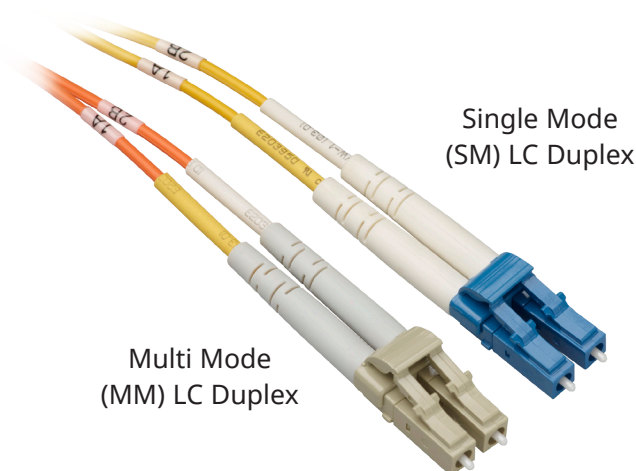
Figure 8: Photo of Single Mode (SM) and Multimode (MM) duplex LC connectors. Either one will connect to the SFP+ but the MM version (orange + grey) would be incorrect and the CPRI link between BBU and RRH would not operate

2. Incorrect fiber type used. The SFP+ discussed in this article requires single mode (SM) fiber, terminated in duplex LC connectors. Generally the jacket color for SM fiber is yellow. The core of SM fiber is 9 μm in diameter, and the ferrule (the opaque white part you see) is 1.25 mm in diameter for an LC connector. Compare that with a multimode (MM) fiber terminated in duplex LC connectors. The ferrule of the MM fiber is also 1.25 mm, however the core is either 50 μm or 62.5 μm , and the jacket color for MM fiber is usually orange. If a MM fiber is used in a SM system, or vice-versa, there will be problems and the system will be inoperable. Therefore, it is extremely important to always use the correct fiber type which is matched to the SFP(+) type being used in that particular system. To the naked eye, you cannot see the difference between SM and MM fiber simply by looking at the LC connector and the visible 1.25 mm ferrule (typically white color for both SM and MM types of fiber).

8. Connectors not fully seated into the SFP modules. These LC connectors (duplex or simplex) are very small and rather delicate. They have a very small plastic tab (see figure 8) which is designed to lock the LC connector once it is inserted far enough into the SFP module. The technician or installer must listen carefully for a click sound which will occur as the locking tab springs upward into the designated opening for it once the connector has been inserted fully. To release the LC connector(s) from the SFP module, you simply press downwards on the locking tab and while holding the tab down, pull the connector out carefully. This is very similar to how CAT 5e or CAT 6 twisted pair cables lock and unlock from their corresponding jacks. Often the environment where the SFP based system is being deployed may be very noisy and the connector locking click sound cannot be heard. The technician or installer may think that it has been fully inserted but finds out later that it wasn't properly seated all the way and this was the cause of the problem. With such a small optical link budget, even the smallest gap between the fiber end and the receiver or transmitter will result in a huge loss of signal.
