External PIM Remediation using PIM Shield™ roofing technology

Executive Summary

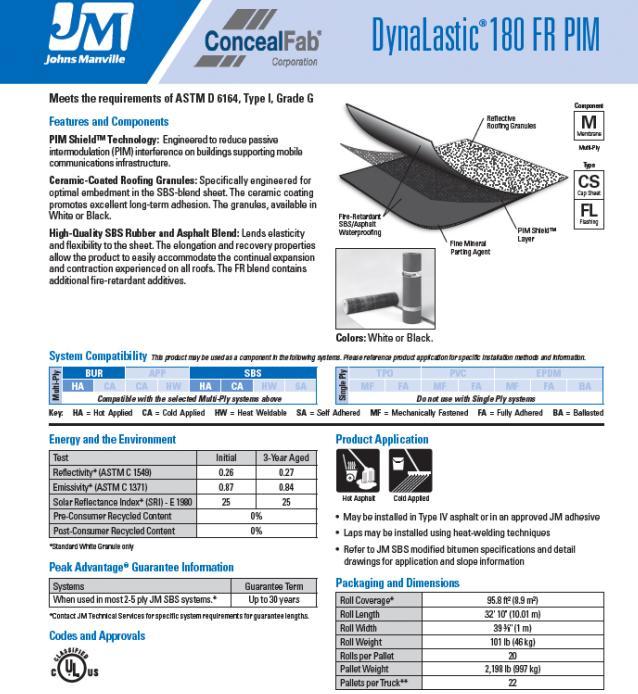
The PIM mitigating material installed at this site was DynaLastic[™] 180 FR PIM, Figure 1. This is a multiply Styrene-Butadiene-Styrene (SBS) modified bitumen roof membrane manufactured by Johns Manville and sold through ConcealFab. The material includes ceramic coated roofing granules bonded to the top surface with a special PIM mitigating layer sandwiched in the middle between two SBS modified bitumen layers. The material can be installed using industry-standard hot asphalt or cold adhesive processes.

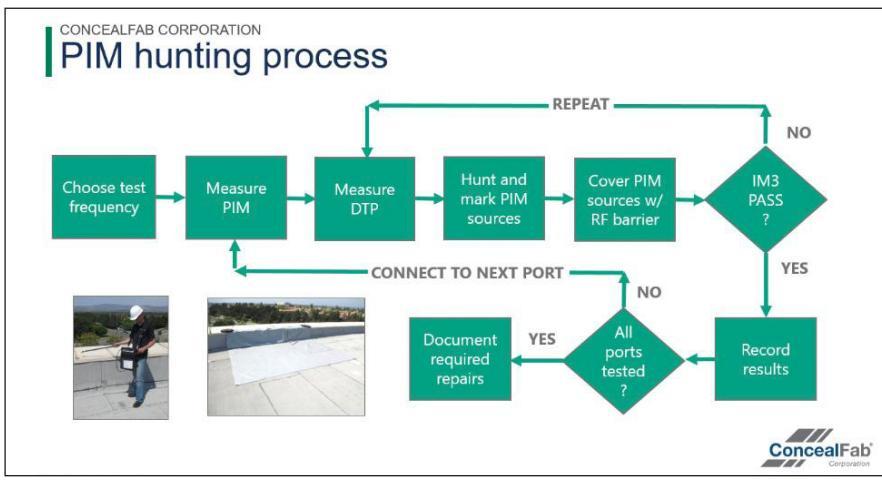
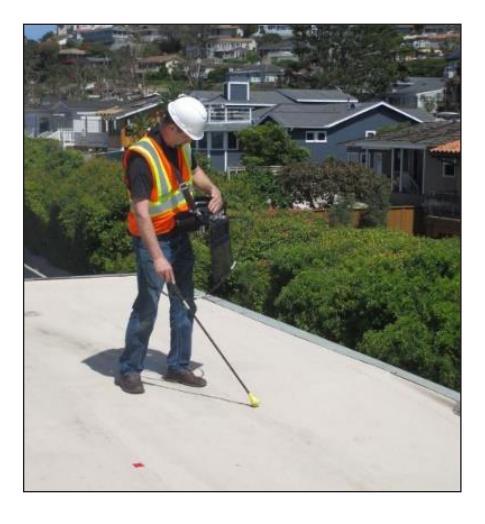
Figure 2

performed the RF measurements on this site following the external PIM investigation process outlined in Figure 2. PIM source locations were identified using Anritsu's PIM Hunter probe as described in Anritsu application note 11410-00992. ConcealFab PIM blankets, part number 007640-120060, were used to cover the PIM sources once identified.

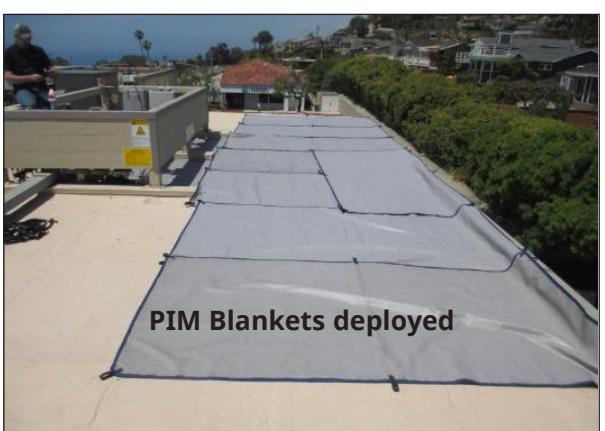
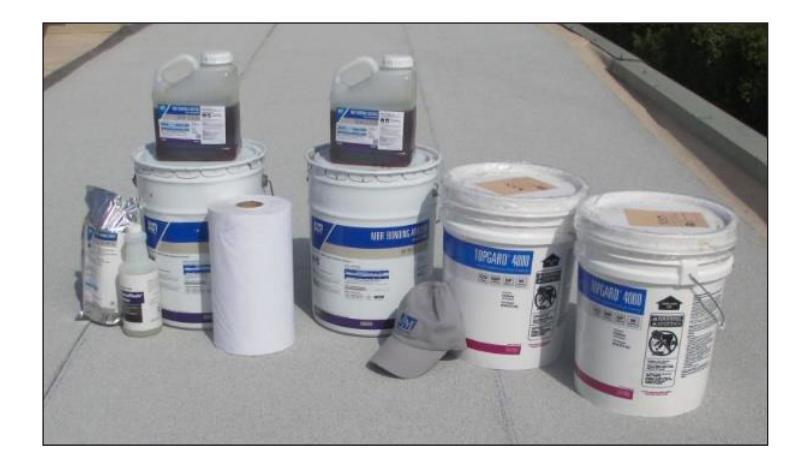
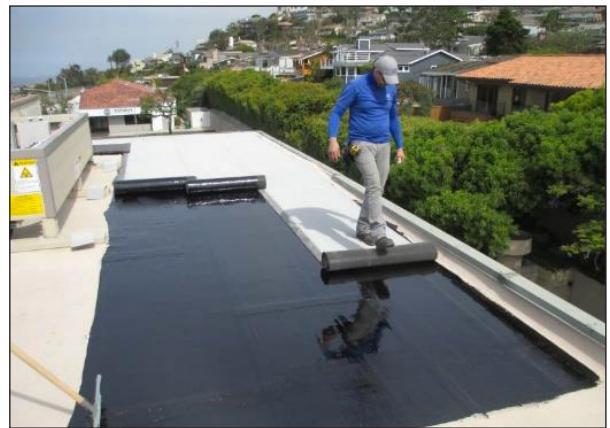
A significant percentage of the area in front of and directly below the sector antennas was found to be generating PIM. Covering those areas with PIM blankets reduced the sector PIM to better than –90 dBm on all ports. PIM Blankets are useful as an aide during the test and measurement process but are not suitable as a long-term mitigation solution.

Port identification	Starting PIM	PIM with blankets deployed	Improvement
1 Violet	–54.1 dBm	–90.1 dBm	36.0 dB
2 Violet	–55.9 dBm	–95.5 dBm	39.6 dB
3 Violet	–52.0 dBm	–97.2 dBm	45.2 dB
4 Violet	–62.2 dBm	–91.7 dBm	29.5 dB

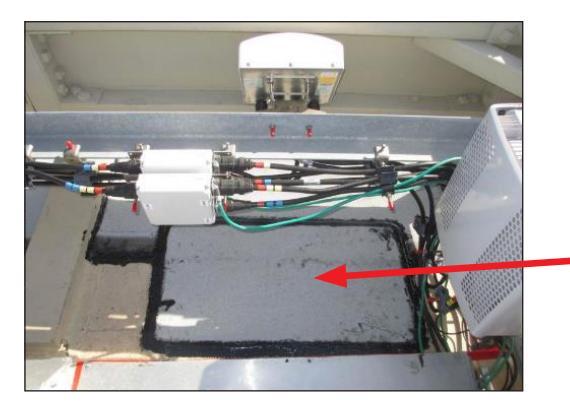
PIM Shield rpofing installed

Additional material required under one antenna to achieve desired performance

The PIM Shield roofing material was then permanently installed using MBR bonding and flashing adhesives per Johns Manville standard installation procedures. After installation, PIM was measured again to validate performance. A small area directly below one antenna required additional coverage to achieve the desired PIM performance. This area had been covered during the PIM blanket deployment but had accidentally not been covered with roofing material.

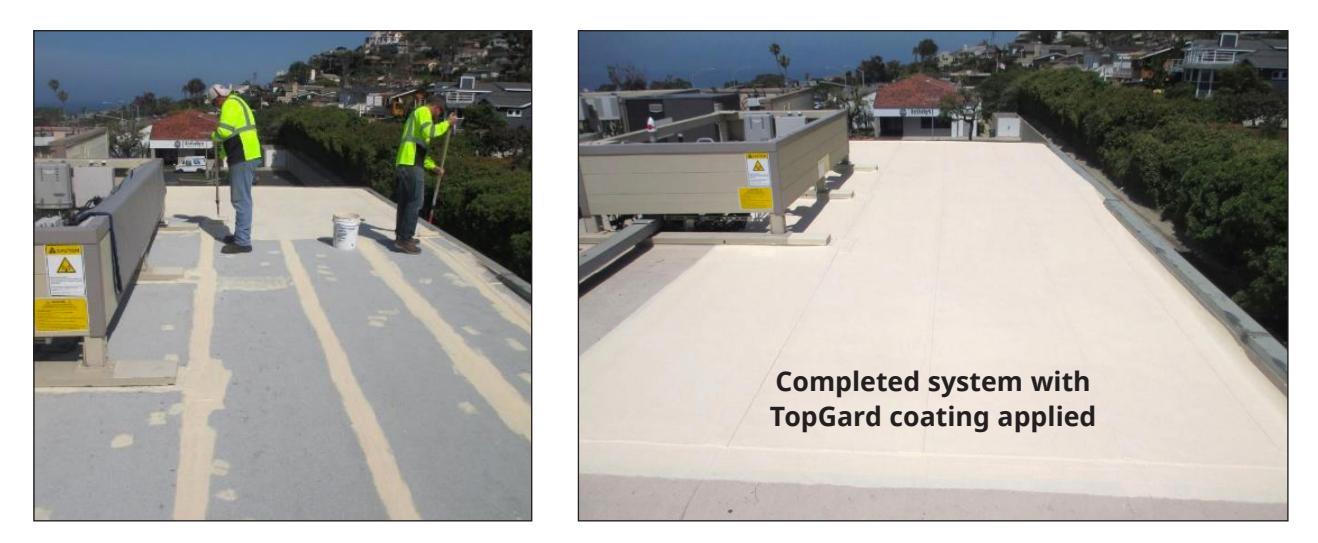
For added protection and to meet local aesthetic requirements, a layer of TopGard 4000 acrylic elastomeric coating was applied over the PIM Shield roofing material.
