# X-ray Inspection System for Package Check

***XR75***  
**Packing Check**

Introducing the XR75 Packing Check specialized for package integrity checks.

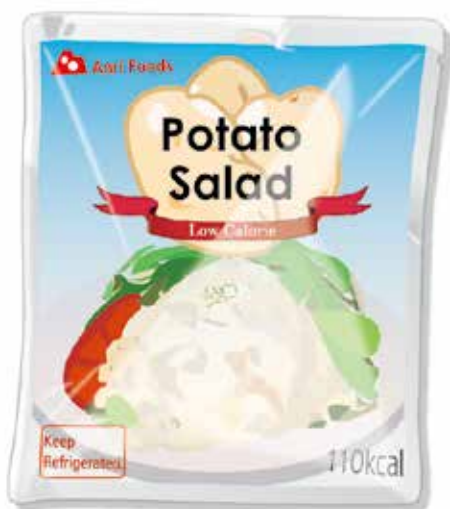
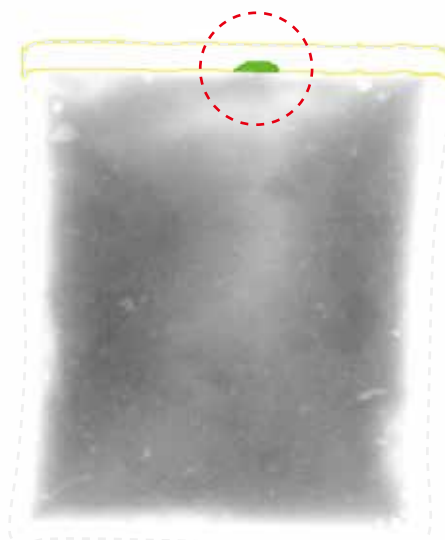
**Inspection of potato salad in a pouch.**

The seal area that contains product absorbs more X-rays than the normal seal area.

Product caught in the seal area absorbs more X-rays

X-ray transmission image of retort pouch curry

The XR75 Packing Check is specially designed for detecting seal defects in food packages. X-ray absorption rate can vary depending on the thickness of the seal area on the package. The Packing Check generates the alarm when detecting defects in the seal area by measuring the difference in x-ray absorption between the normal and the defective seal areas. Wrinkles on the seal area can be identified on the same principle.

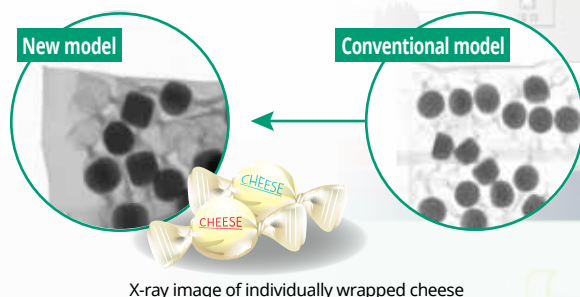
X-ray image of individually wrapped cheese

The Packing Check is equipped with the new x-ray sensor developed in-house using our years of experience. This new sensor enables the system to accurately identify the seal area of various types of packaging. The XR75 Packing Check helps achieve the highest product quality by detecting a small amount of the product caught in the seal area, which is hardly identified by visual inspection.

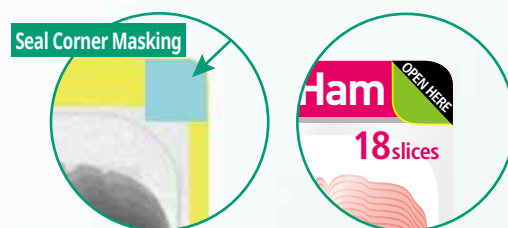
Deformation such as wrinkles and curl on the seal corner of vacuum packs or trays can trigger false rejects during the inspection of sealing integrity by conventional inspection systems. The Seal Corner Masking enables the system to maintain the optimum inspection performance, reducing the possibility of false rejection on the deformed seal corner.

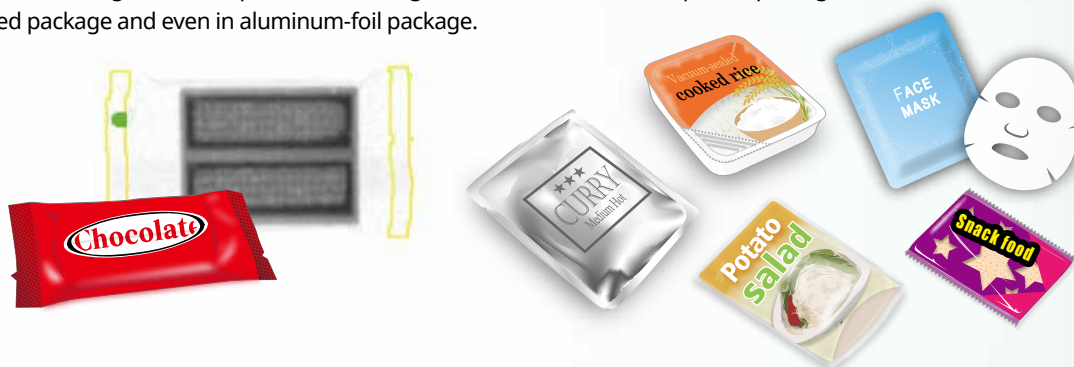
It is difficult for cameras for vision systems to capture contaminants in colored packages. The XR75 Packing Check is capable of detecting seal defects in semi-transparent package, colored package and even in aluminum-foil package.

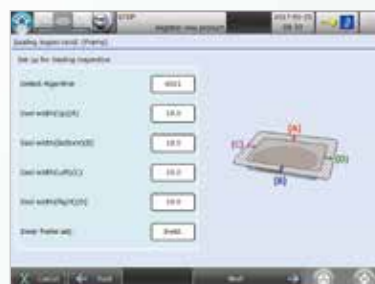
- Product Registration Navigation simplifies setting procedures with step-by-step illustrated instructions.
- Setting procedures for package check are simplified.

Packaging material is recognized by simply entering the seal width. The optimal inspection settings are automatically determined without the complicated adjustment.

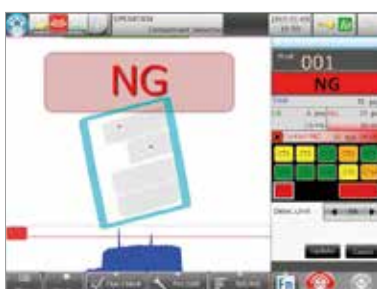
#### [Easy to adjust sensitivity]

Detection levels are visually shown on the main screen to enhance usability. Quick sensitivity adjustments are possible (based on operator level).

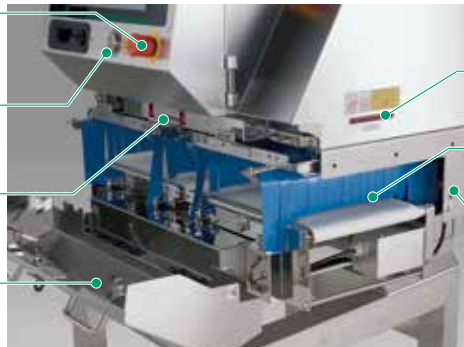
#### Anritsu safety mechanism

Cuts power to x-ray and drive circuits, stops the conveyor and x-ray radiation

Turning the key to OFF stops x-ray radiation completely

Opening the cover stops x-ray radiation completely

Opened/Closed using x-ray irradiation ON/OFF key. Opening the cover stops x-ray radiation due to the x-ray shield cover open/close sensor

The lamp is lit during x-ray radiation

Prevents x-ray leakage

Interrupting the sensor for a certain period of time stops x-ray radiation
